PUNTLAND HIGHWAY  
AUTHORITY

ROAD CONDITION  
ASSESSMENT SURVEY  
REPORT

GAROWE – BOSASO TARMAC  
ROAD

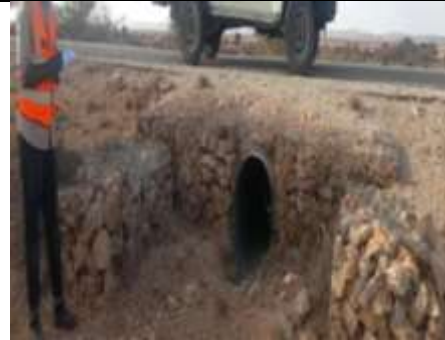
Lat 8.588438  
 Long 49.106712  
 Photo 36- showing Culvert outlet

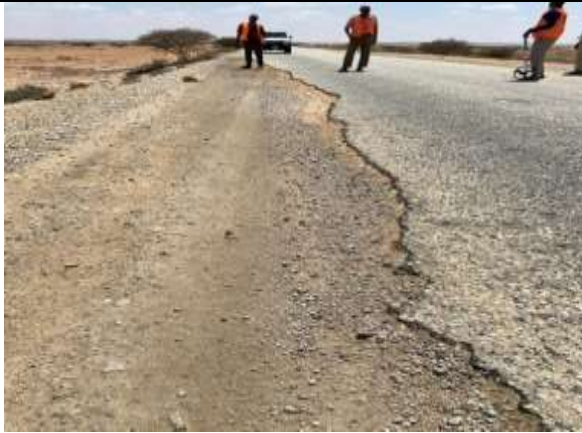
Shoulder erosion picture (RM4)  
@ Sinujiif-Dangorayo section

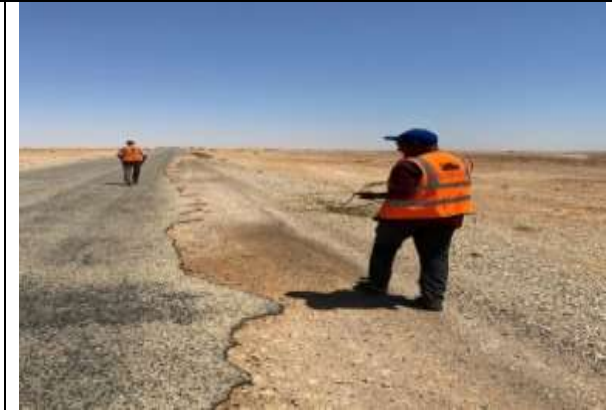
Shoulder erosion picture (RM4)  
@ Sinujiif-Dangorayo section

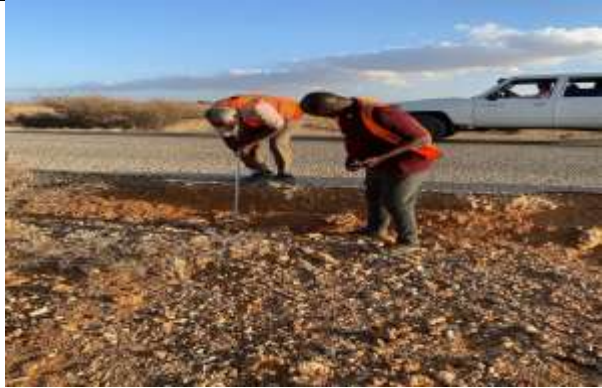
**Washed Embankment (RM5)  
@ Sinujiif-Dangoroyo section**

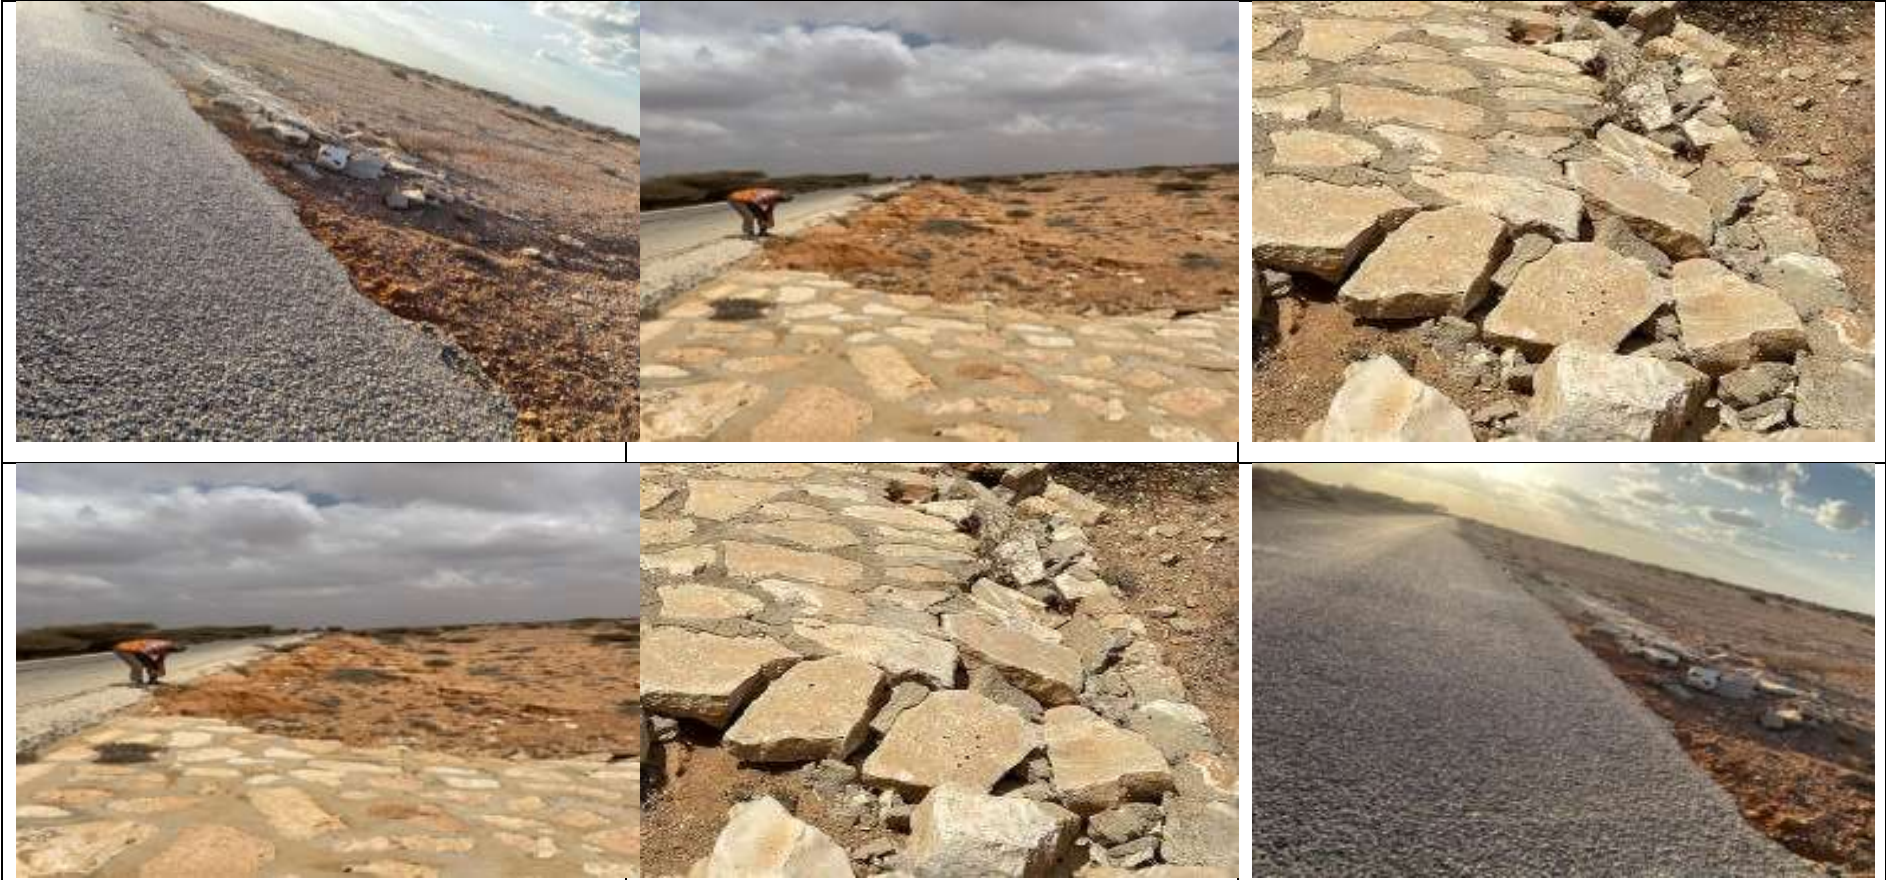
#### 8.2.10 Photos : Stone Pitching for Section 2- Sinujiif-Dangorayo

<b>NO</b>	<b>COORDINATES</b>		<b>LENGTH</b>	<b>AVERAGE WIDTH</b>	<b>DEFECTS (RM5)</b>	<b>PRPOSED IMPROVEMENT MEASURE</b>
1	8.58838°N	49.11119°E	3.5	1.1	3 years ago, there were heavy rain falls in Puntland regions which generally defected many spots of the road specially road embankment with stone pitching due to in adequate drainage capacity	The defected stone pitching on the embankment is essential for protection against erosion of the embankment and has to be repaired
2	8.58839°N	49.11128°E	4.4	1.3	3 years ago, there were heavy rain falls in Puntland regions, which generally defected many spots of the road specially road embankment with stone pitching due to in adequate drainage capacity	The defected stone pitching on the embankment is essential for protection against erosion of the embankment and has to be repaired
3	8.58841°N	49.11141°E	1.5	1.2	3 years ago, there were a heavy rain falls in Puntland regions, which generally defected many spots of the road specially road embankment with stone pitching due to in adequate drainage capacity	The defected stone pitching on the embankment is essential for protection against erosion of the embankment and has to be repaired

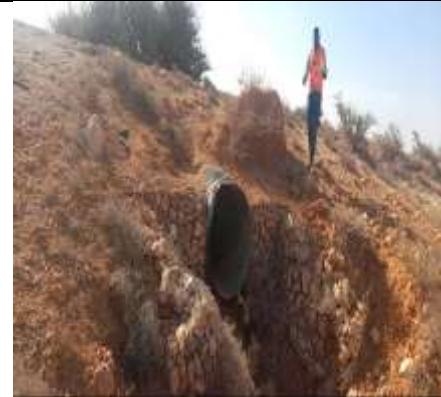
Lat8.930869  
 Long 49.270730  
 Photo 52- showing Culvert outlet

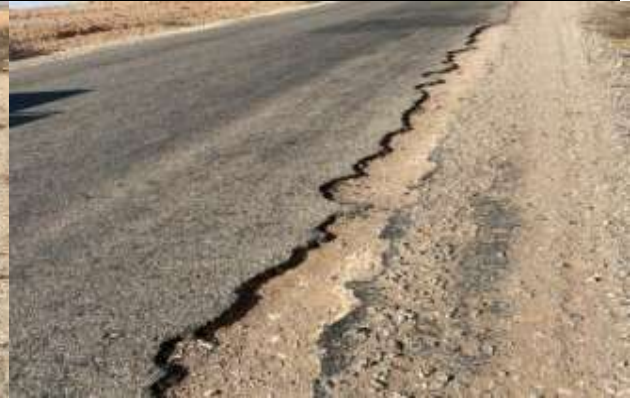
**SHOULDER EROSION (RM4)  
@ DANGORAYO-HAJI KHAYR SECTION**

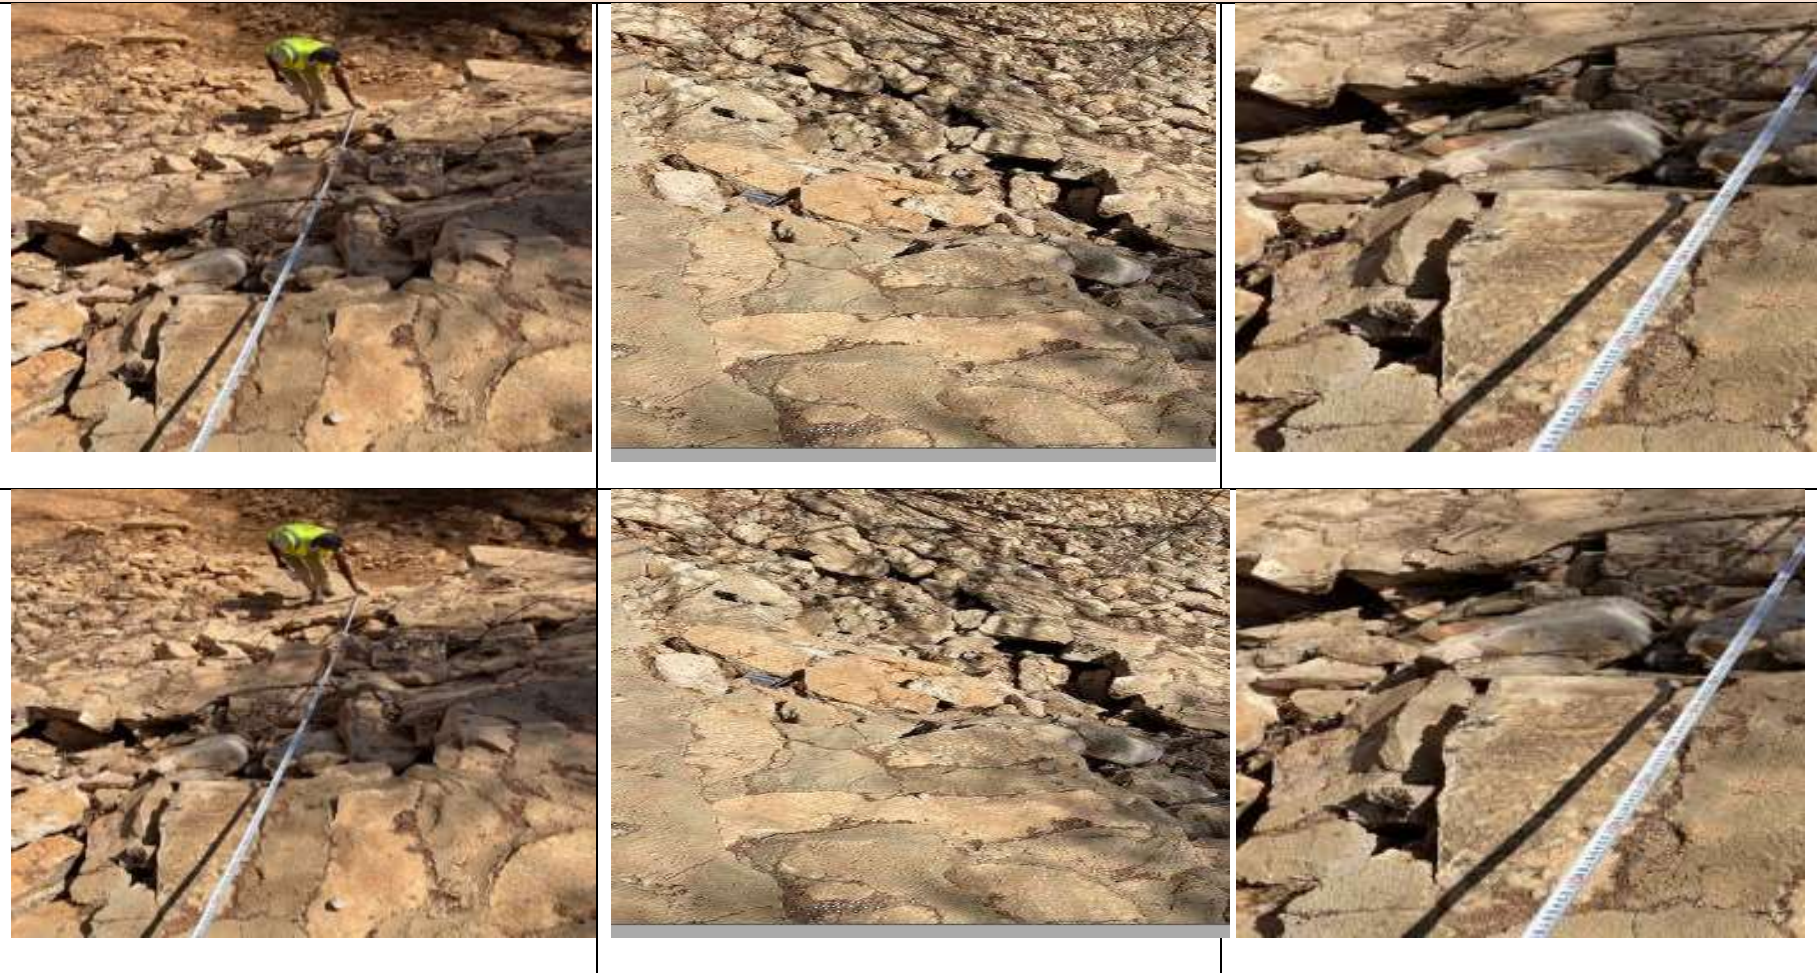
### 8.3.10 Photos: Stone Pitching for Section 3- Dangorayo-Haji Khayr

✓ The length of the eroded stone pitching is 37.70M

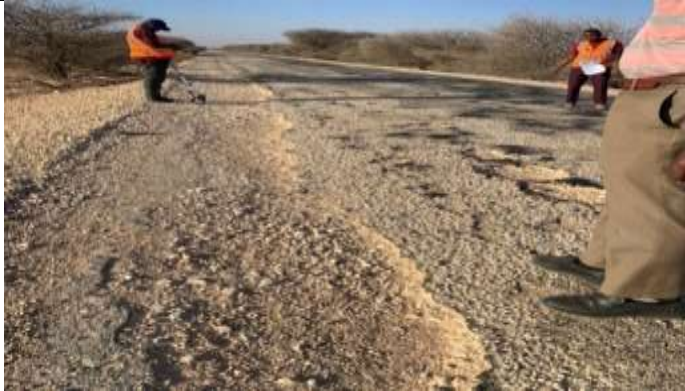
**SHOULDER EROSION (RM4)  
@ HAJI KHAYR-QARDHO SECTION**

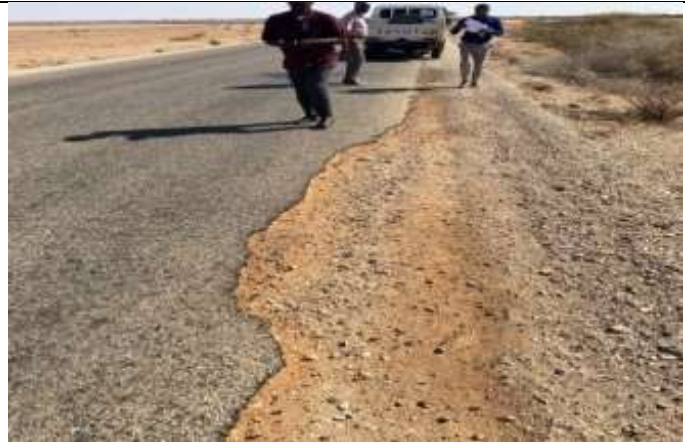
**SHOULDER EROSION (RM4)  
@ HAJI KHAYR-QARDHO SECTION**

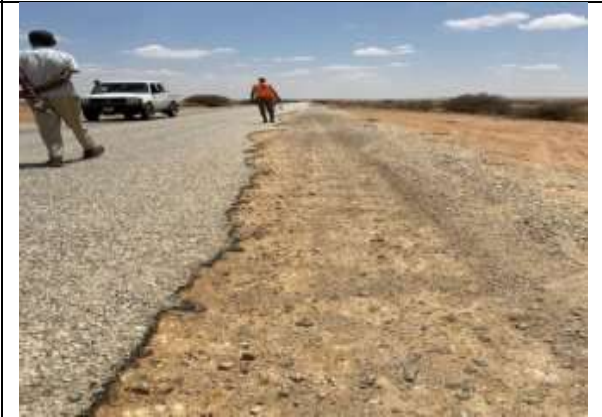
**SHOULDER EROSION (RM4)  
@ HAJI KHAYR-QARDHO SECTION**

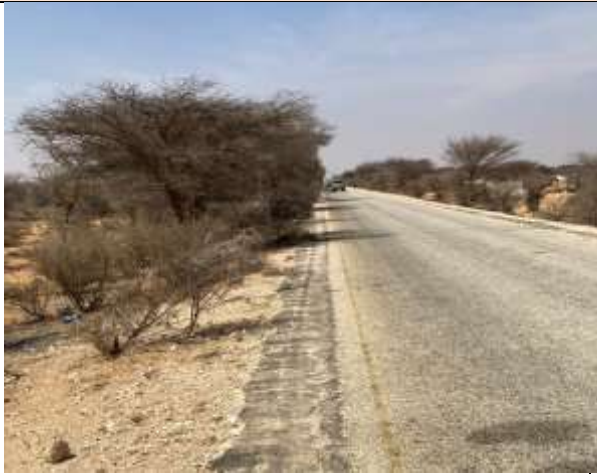
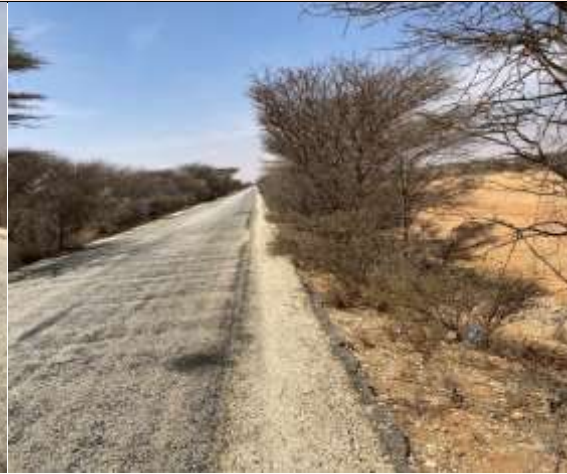
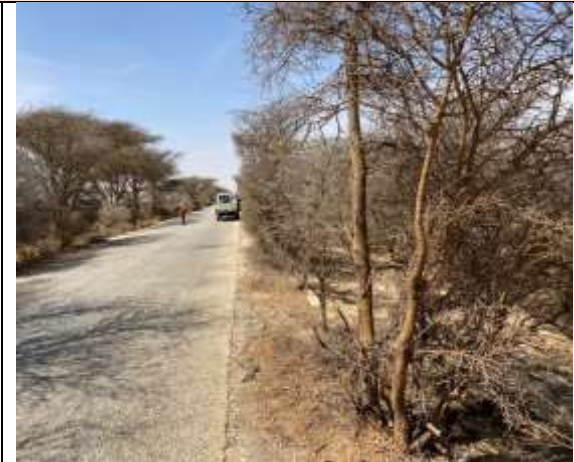
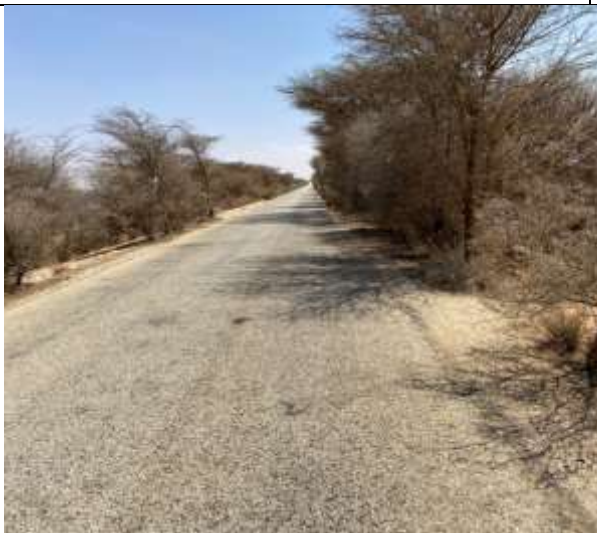
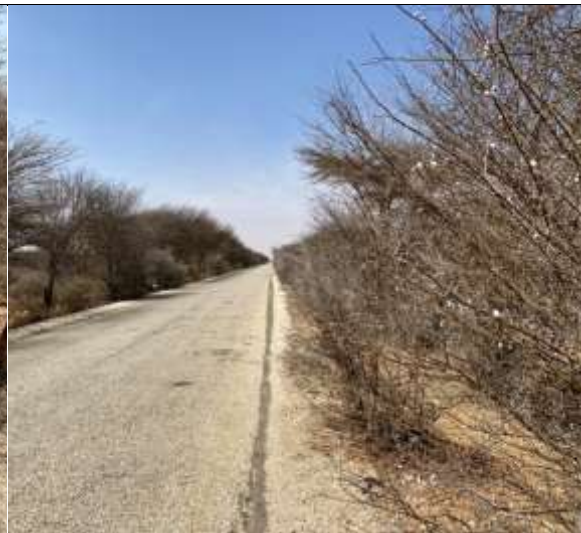
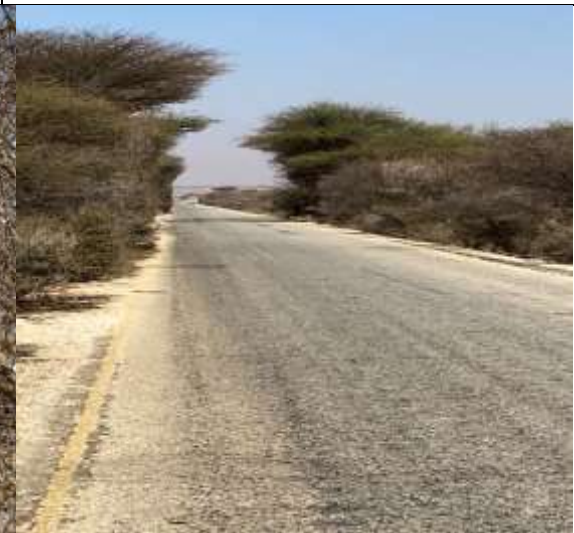
**8.4.10 Photos: Overgrown Vegetation for Section 4- Haji Khayr-Qardho**

✓ The length of overgrown vegetation is 5.950 km

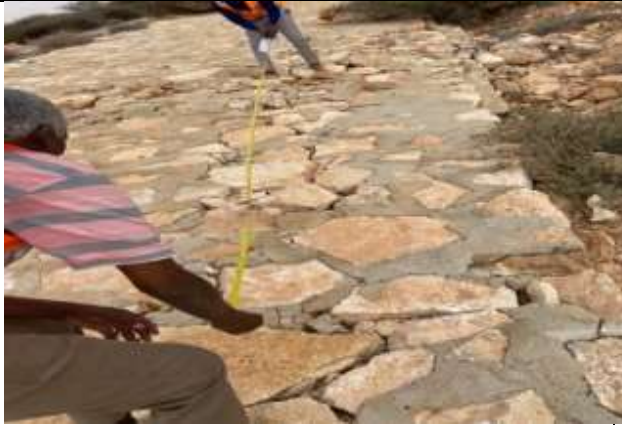
**Stone pitching (RM5)  
@ Haji khayr-Gardo Section**

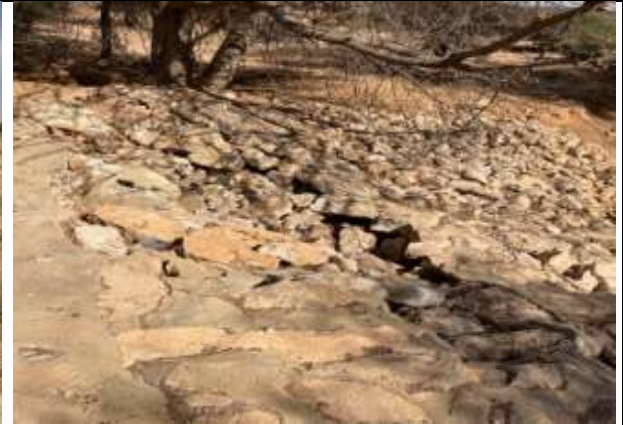
**Stone pitching (RM5)  
@ Haji khayr-Gardo Section**

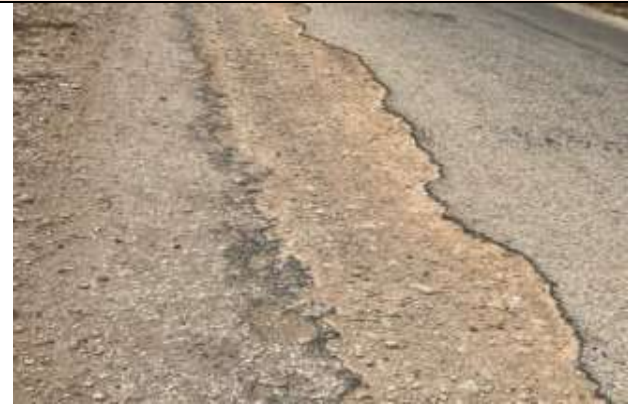
**SHOULDER EROSION (RM4)  
@ GARDO-WACIYE SECTION**

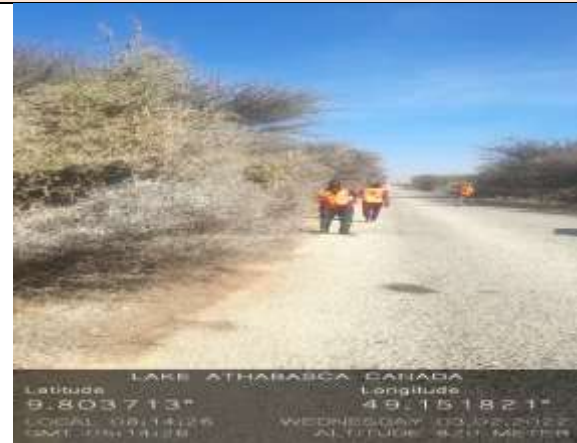
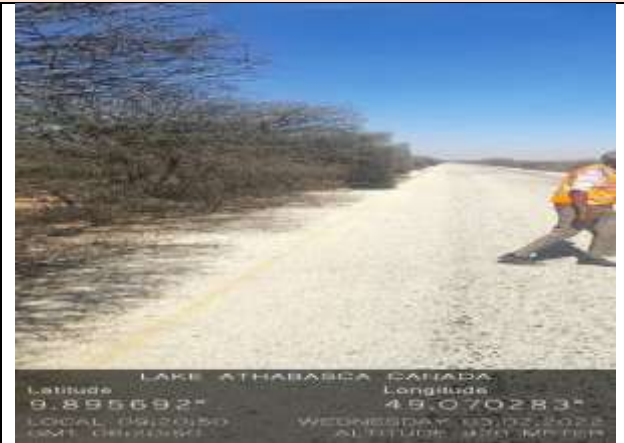
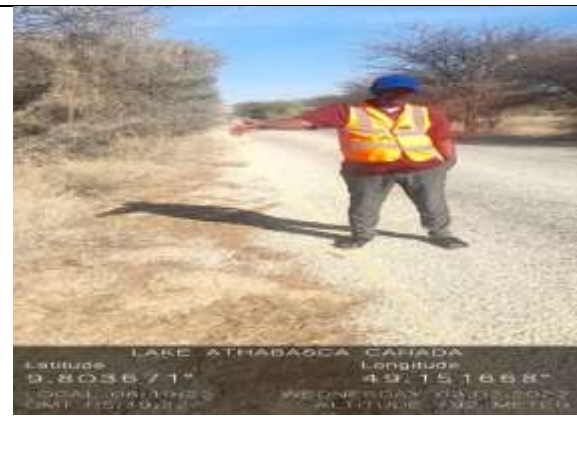
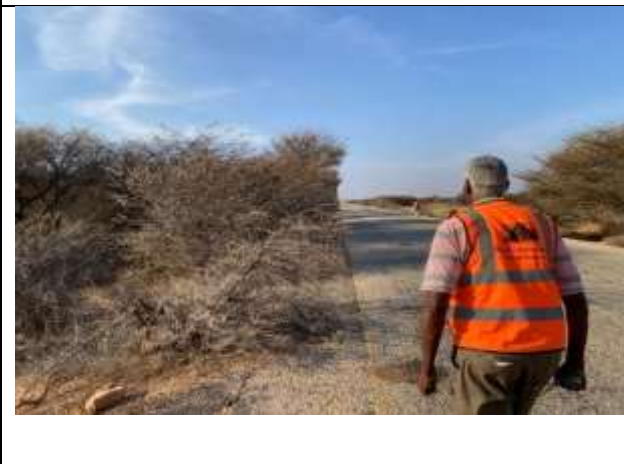
**8.5.10 Photos: Overgrown Vegetation for Section 5- Qardho –Waaciye**

✓ The length of overgrown vegetation is 10.350 km

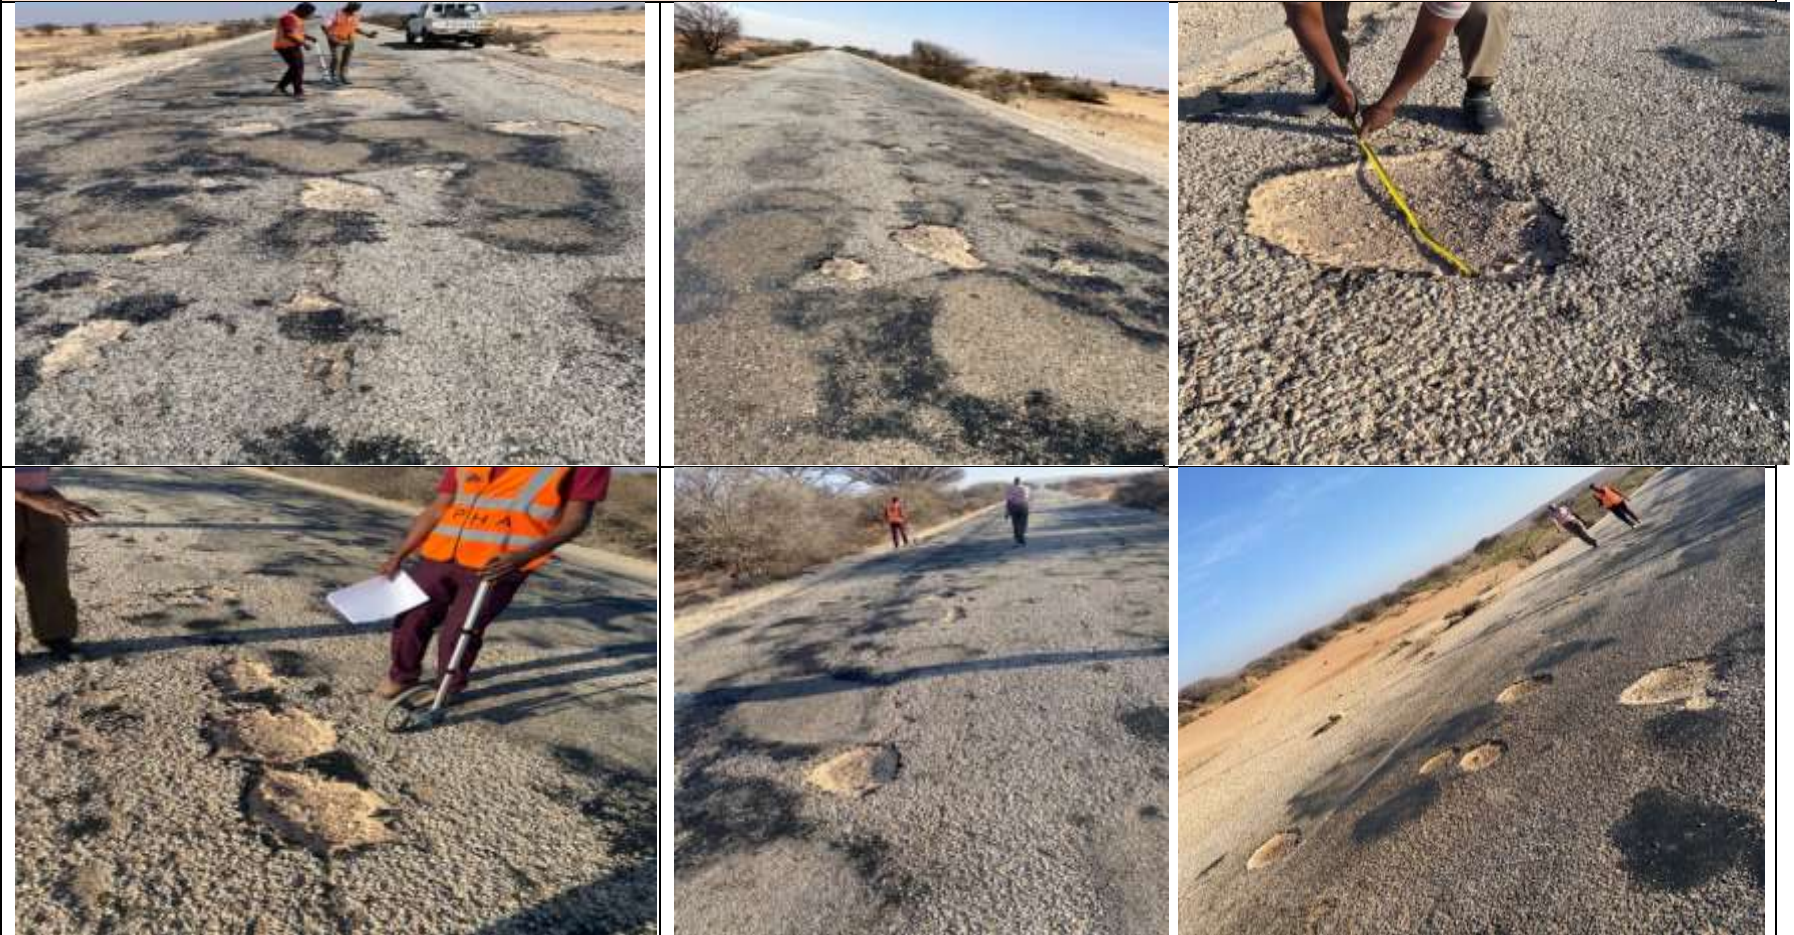
**8.5.12 Photos: Status of Potholes for Section 5- Qardho –Waaciye**

- ✓ The number of small size potholes are 2106 pcs
- ✓ The number of small size potholes are 45 pcs
- ✓ The number of small size potholes are 11 pcs

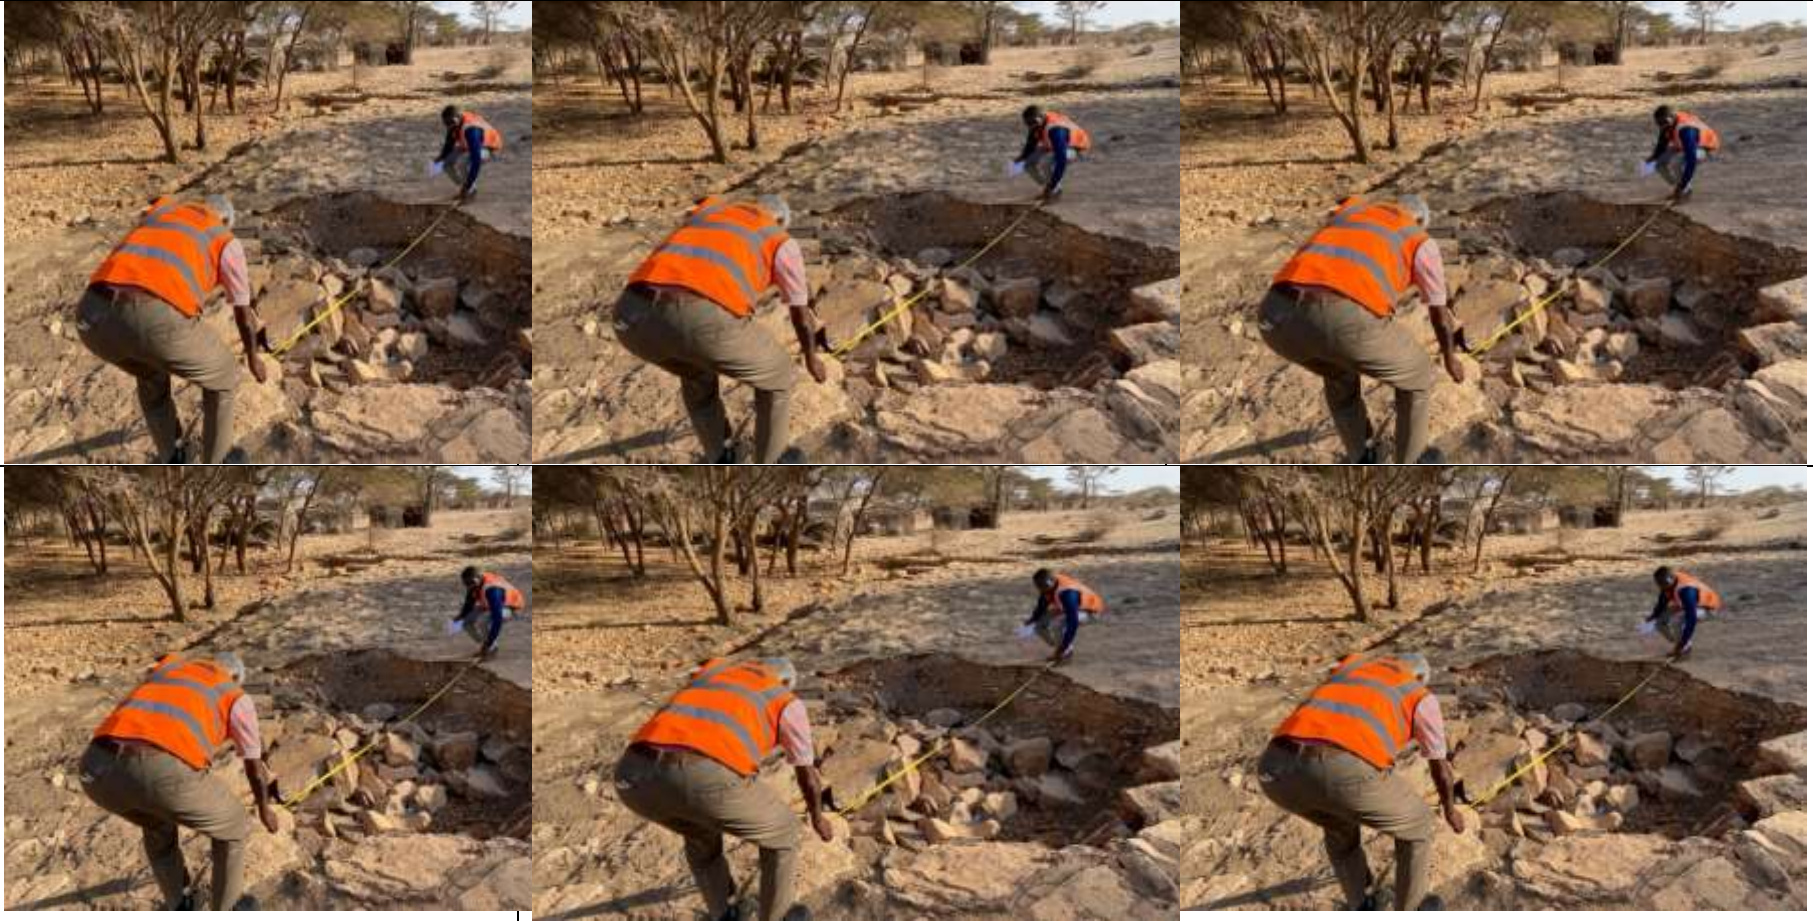
**8.5.14 Photos: Stone Pitching for Section 5- Qardho –Waaciye**

✓ The length of the eroded stone pitching is 5m

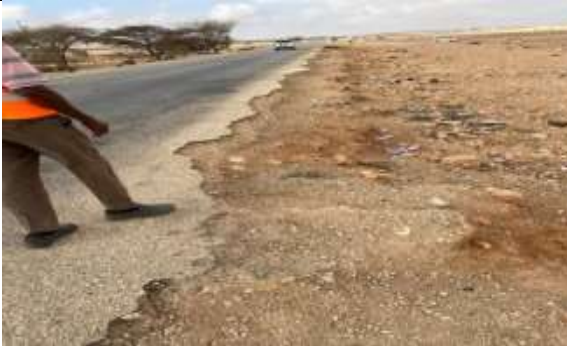
**SHOULDER EROSION (RM4)  
@WACIYE-ARMO SECTION**

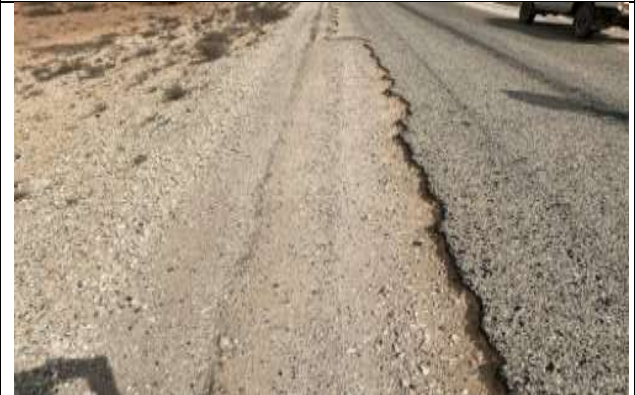
**SHOULDER EROSION (RM4)  
@WACIYE-ARMO SECTION**

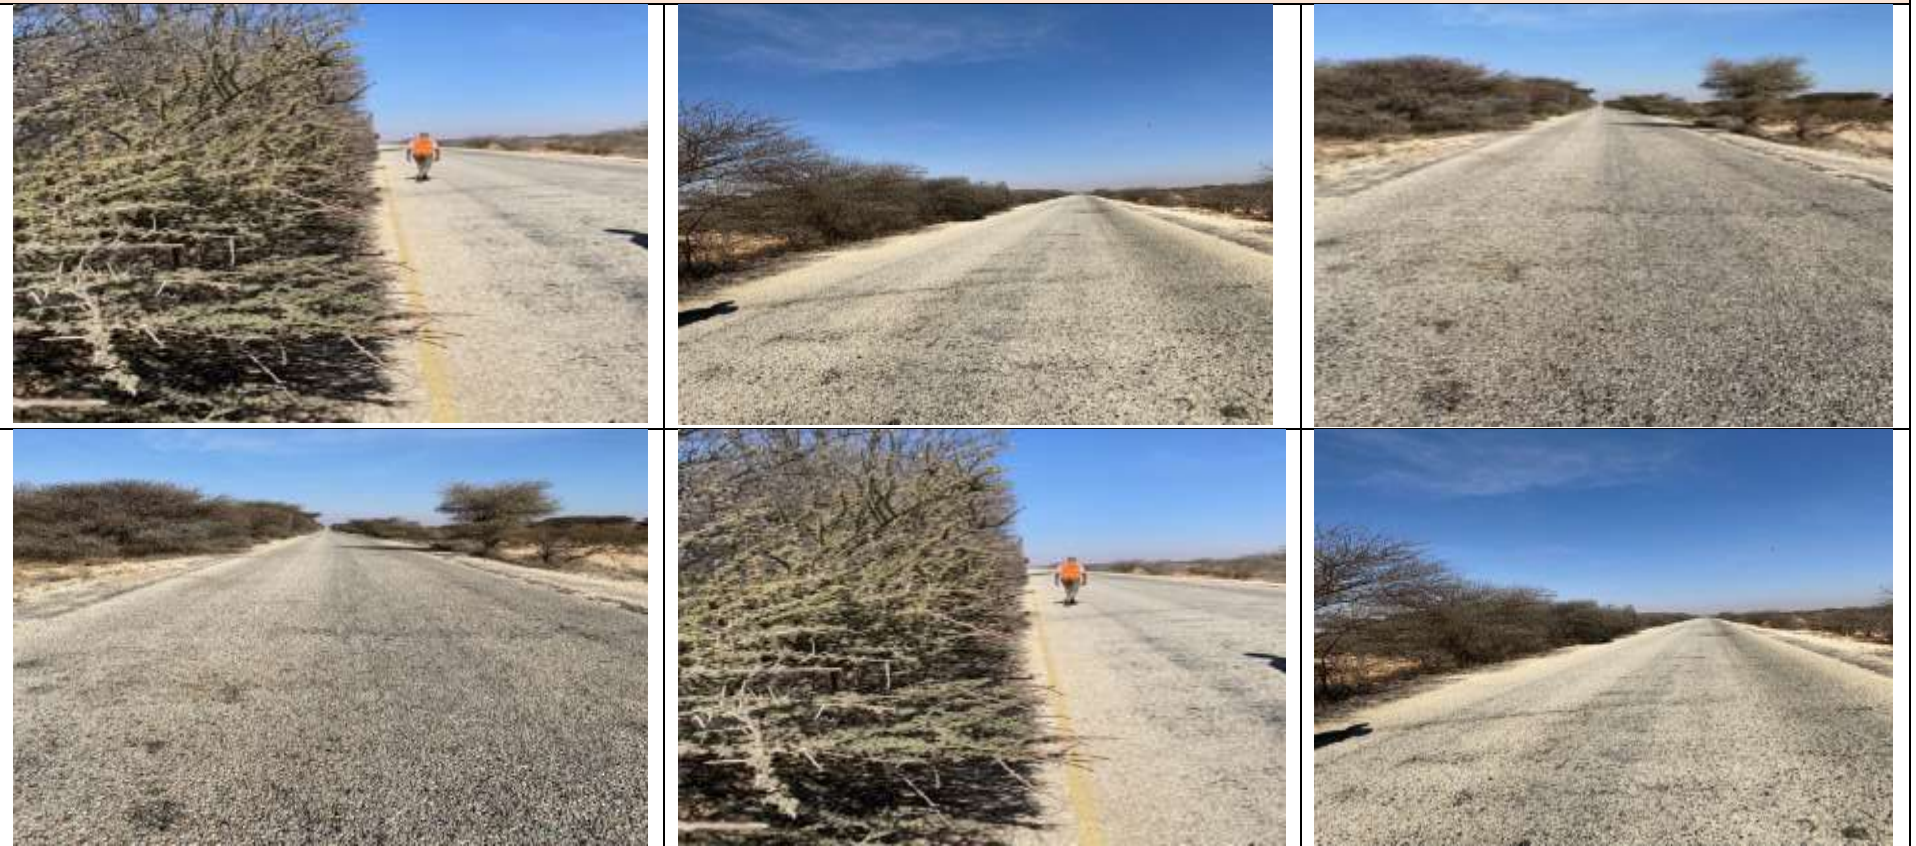
**8.6.10 Photos: Overgrown Vegetation for Section 6- Waaciye-Carmo**

✓ The length of overgrown vegetation is 3.880km

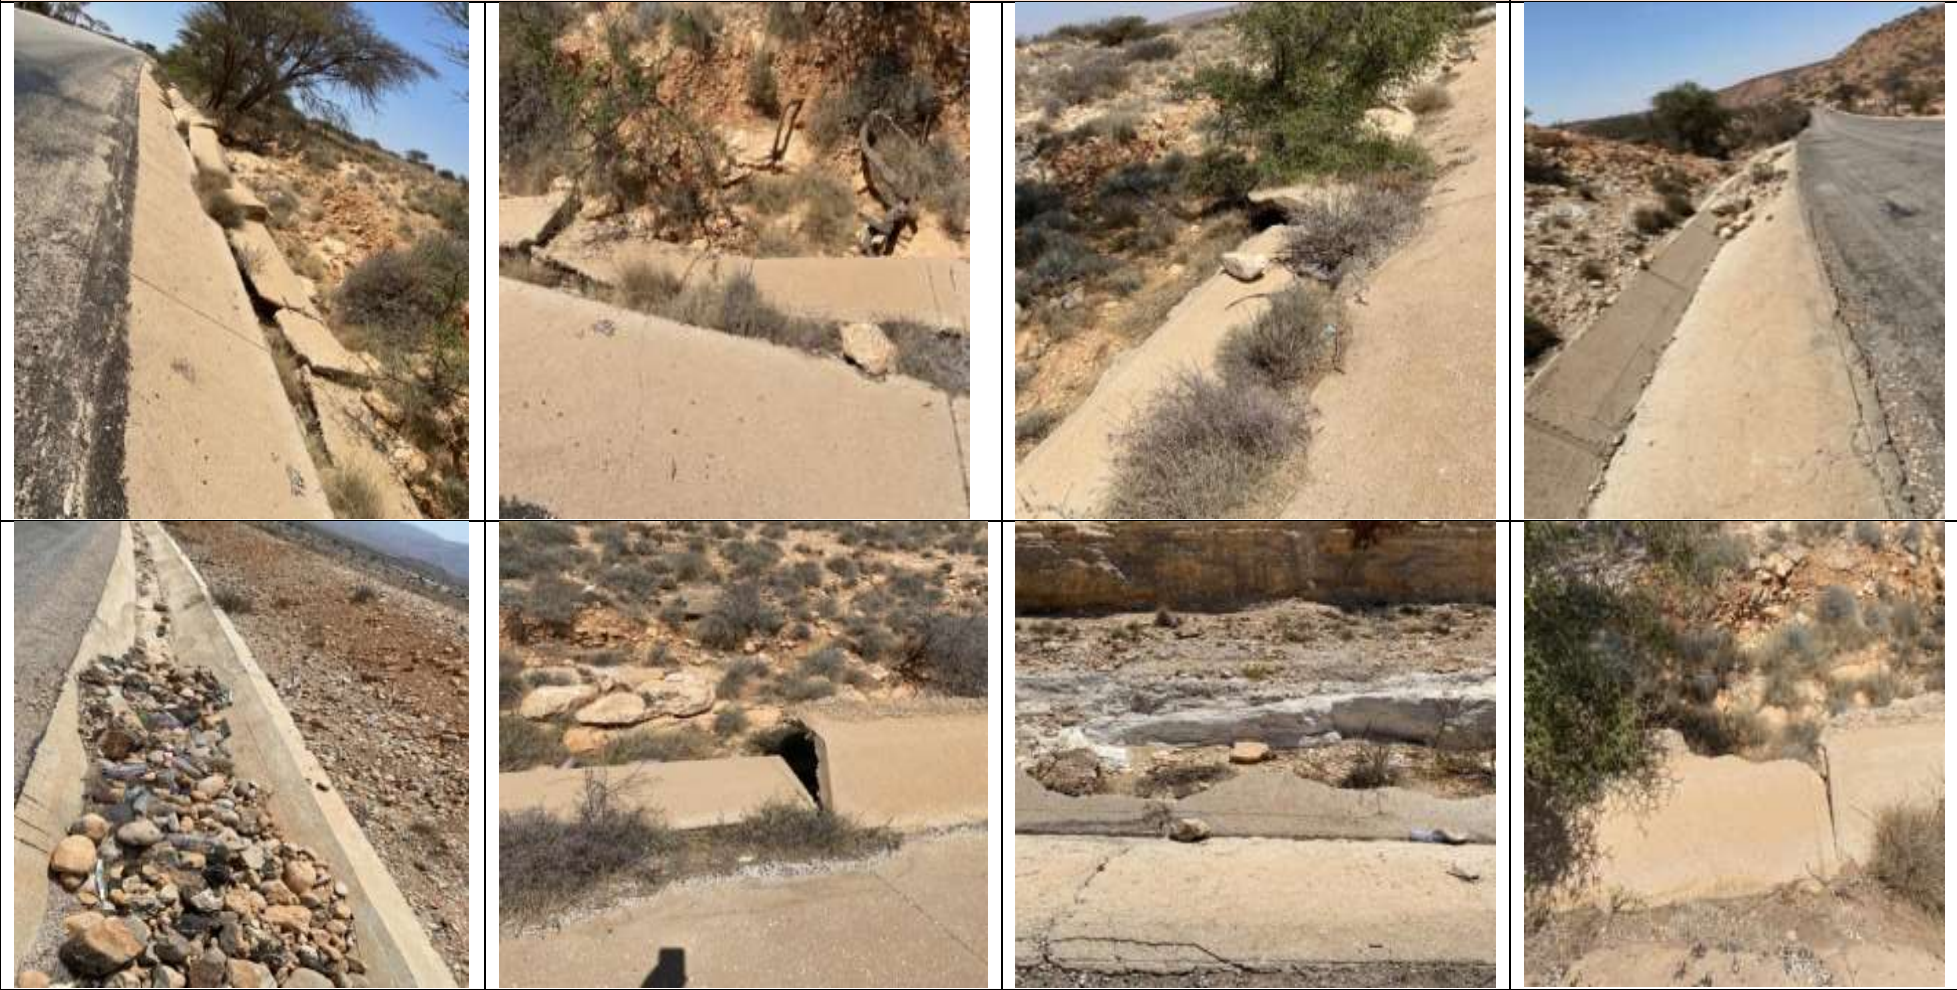
8.6.12 Photos: Drainage for Section 6- Waaciye-Carmo

✓ The length of Accumulated drain canals is 960m

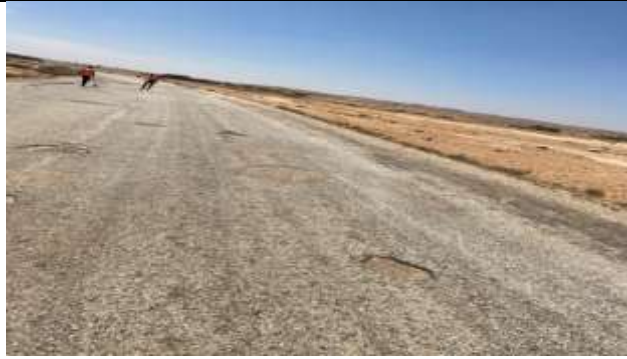
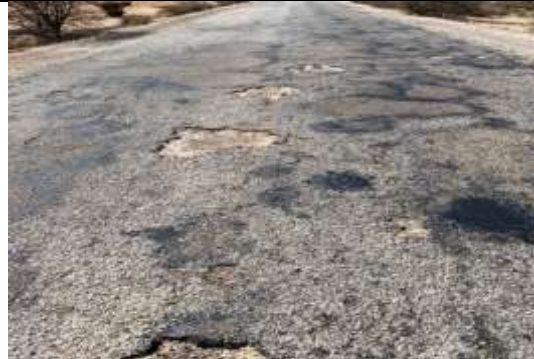
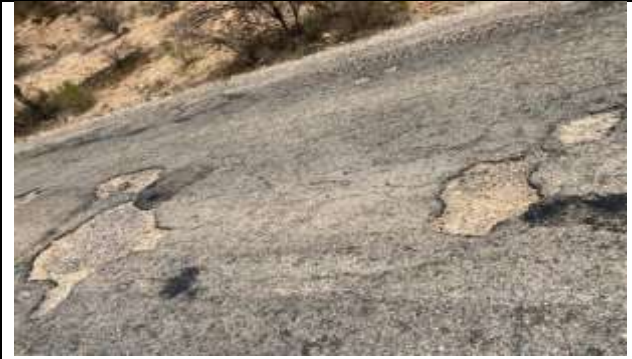
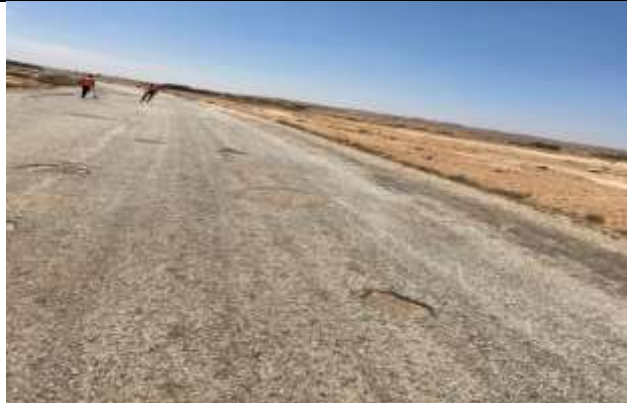
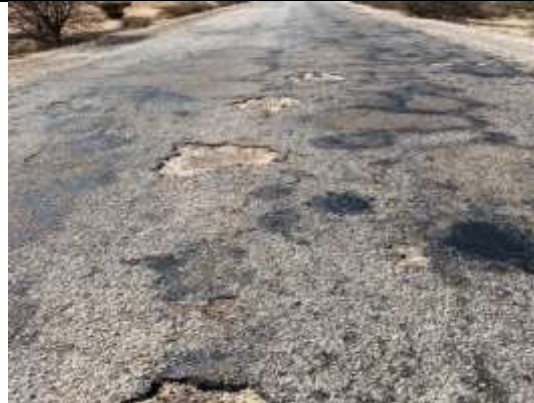
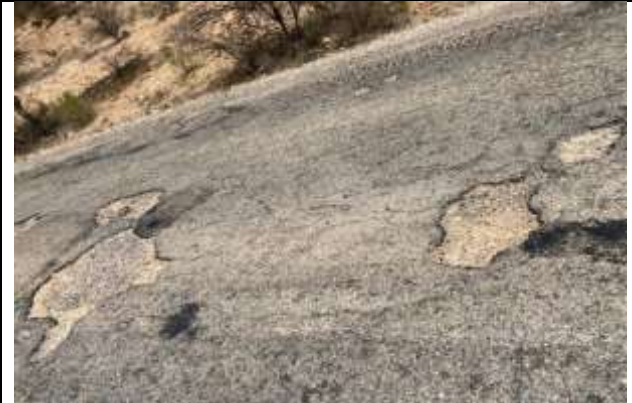
#### 8.6.14 Photos: Potholes for Section 6- Waaciye-Carmo

- ✓ The number of small size potholes are 259 pcs
- ✓ The number of small size potholes are 9 pcs
- ✓ The number of small size potholes are 20 pcs

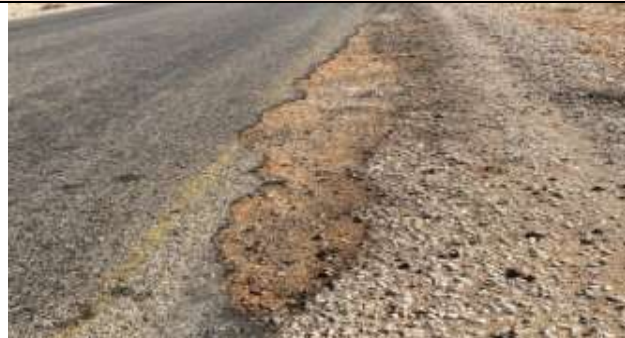
**SHOULDER EROSION (RM4)  
@ ARMO-BOSASO SECTION**

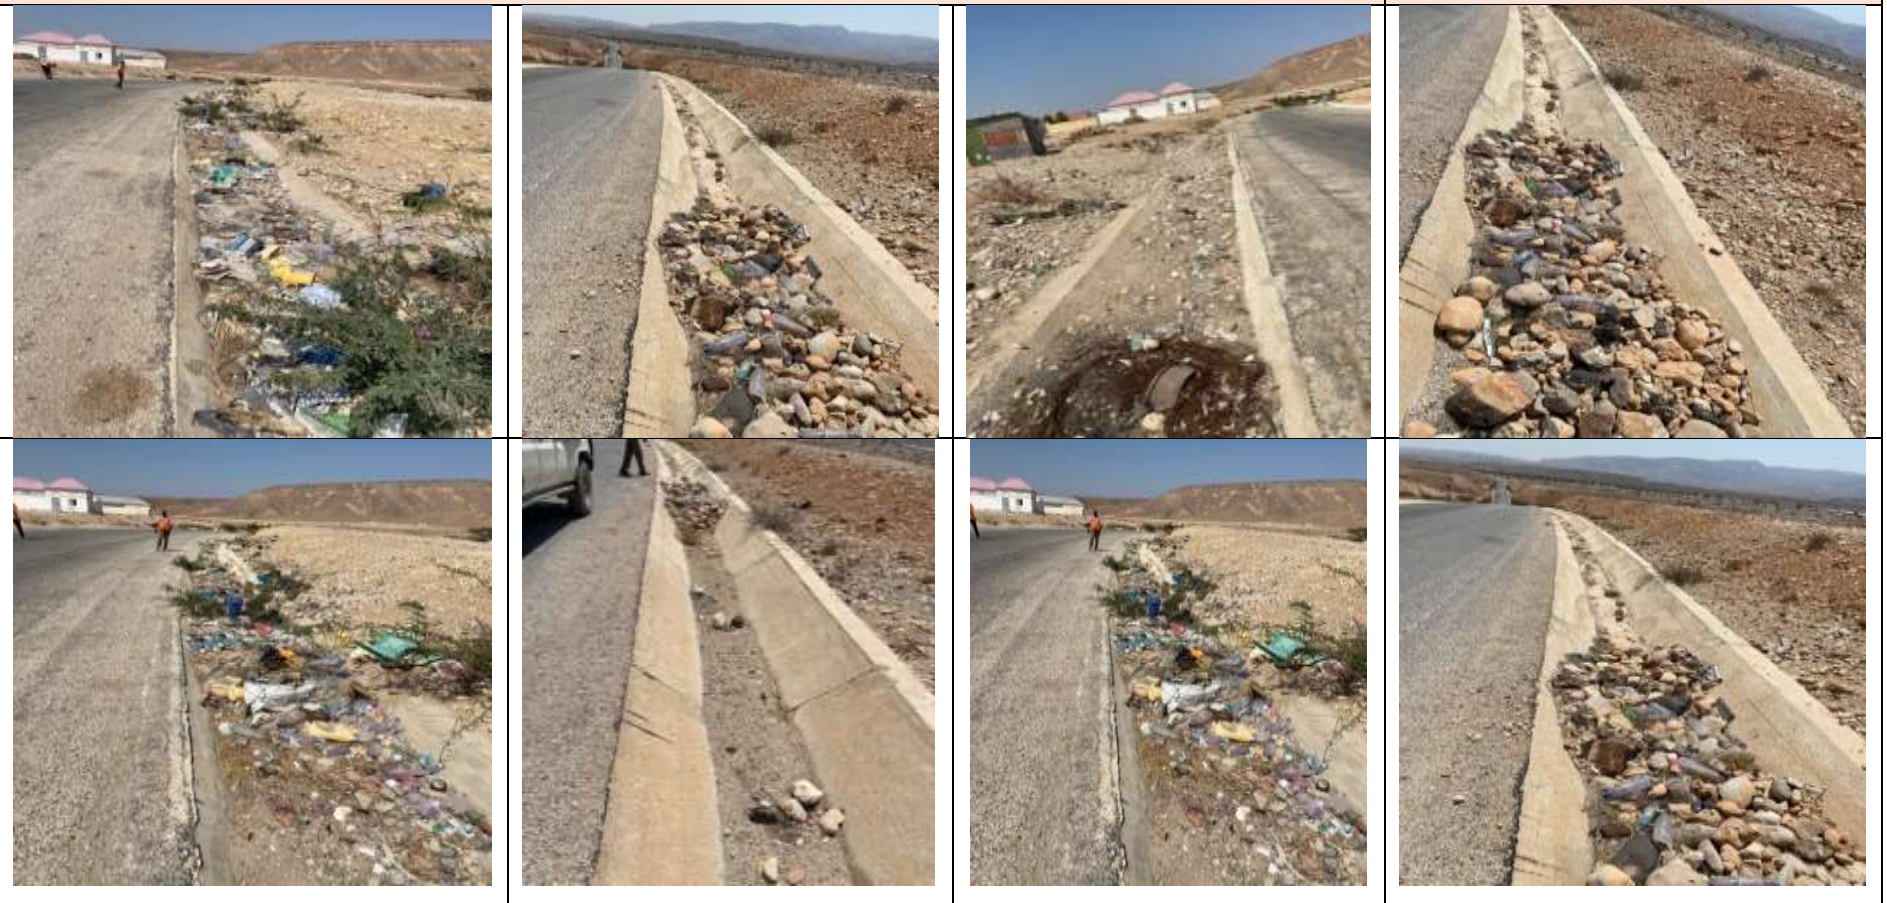
**8.7.8 Photos: Drainage for Section 7- Carmo-Bosaso**

✓ The length of drain canals is 775m

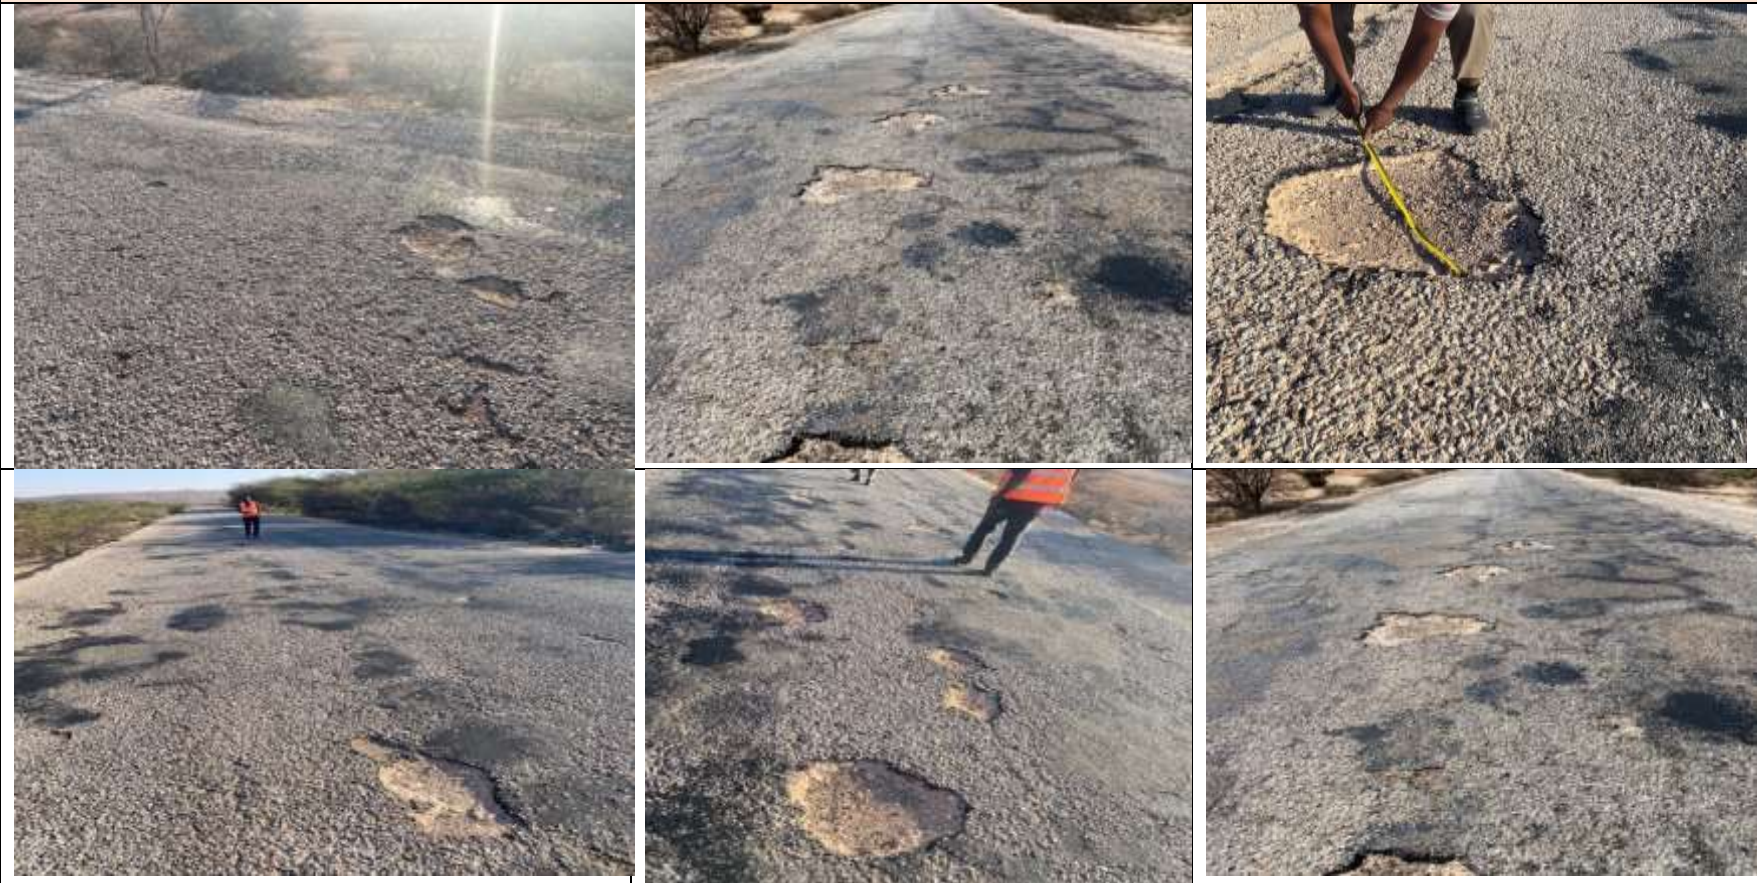
**8.7.10 Photos: Potholes for Section 7- Carmo-Bosaso**

- ✓ The number of small size potholes are 152 pcs
- ✓ The number of small size potholes are 12 pcs
- ✓ The number of small size potholes are 22 pcs
