PUNTLAND HIGHWAY  
AUTHORITY

ROAD CONDITION  
ASSESSMENT SURVEY  
REPORT

GAROWE – BOSASO TARMAC  
ROAD

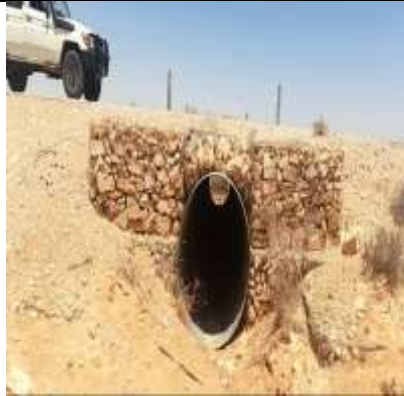
Lat 8.476201  
 Long 48.642633  
 Photo 1- showing Culvert inlet

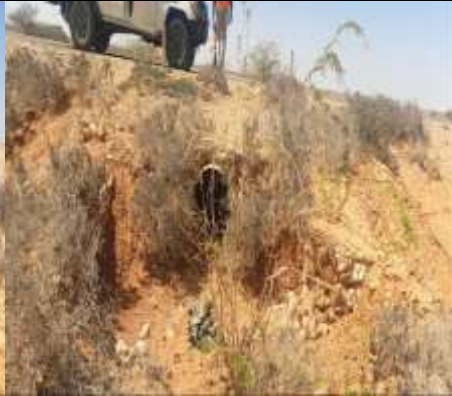
Lat 8.495044  
 Long 48.757774  
 Photo 2- showing Culvert outlet

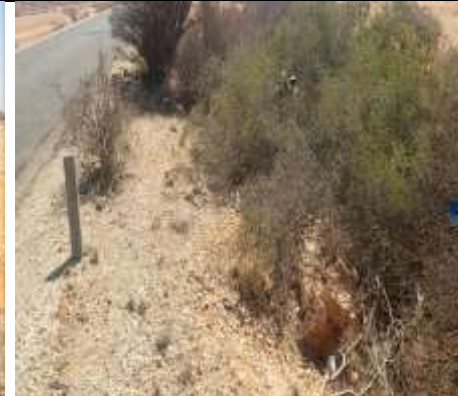
Lat 8.471469  
 Long 48.609832  
 Photo 3- showing Culvert inlet

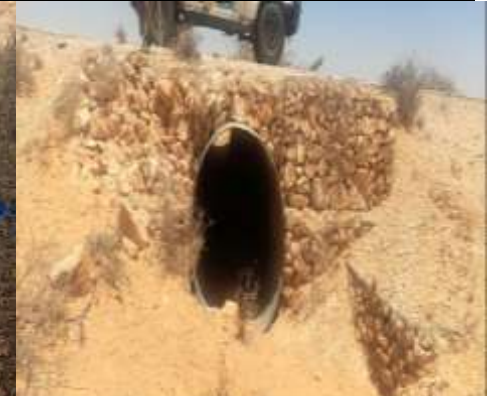
Lat 8.476588  
 Long 48.645032  
 Photo 7- showing Culvert inlet

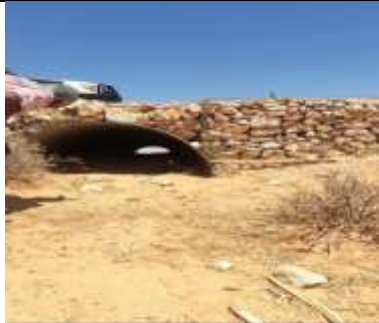
Lat 8.475626  
 Long 48.609832  
 Photo 4- showing Culvert inlet

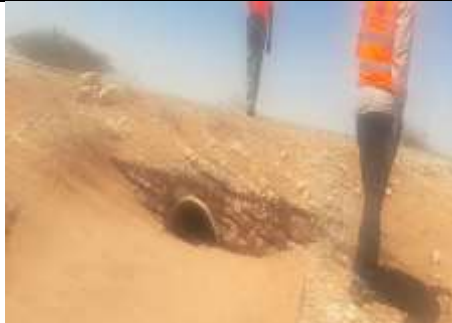
Lat8.488484  
 Long 48.732844  
 Photo 5- showing Culvert inlet

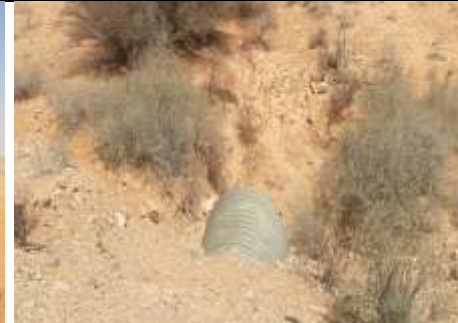
Lat8.475366  
 Long 48.636227  
 Photo 6- showing Culvert inlet

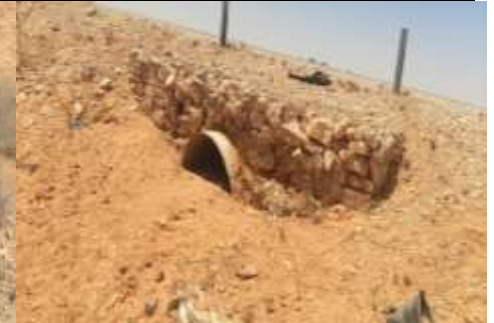
Lat 8.485133<sup>o</sup>  
 Long 48.720127<sup>o</sup>  
 Photo 9- showing Culvert inlet

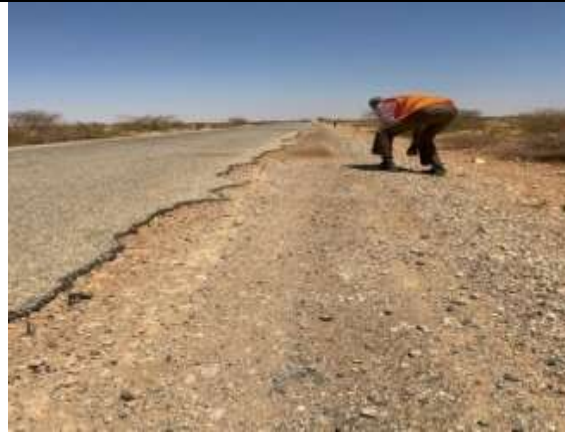
Shoulder erosion picture (RM4)  
@ Sinujiif-Dangorayo section

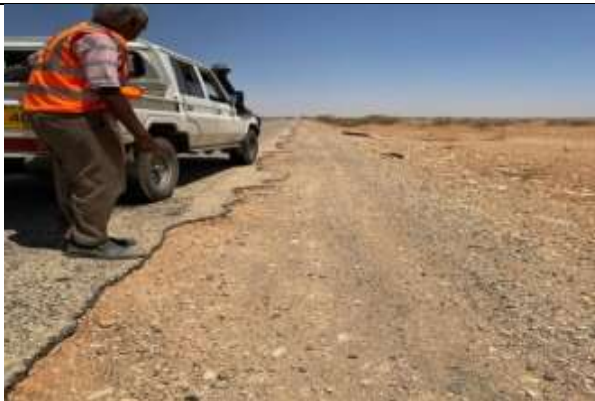
Shoulder erosion picture (RM4)  
@ inujiif-Dangorayo section

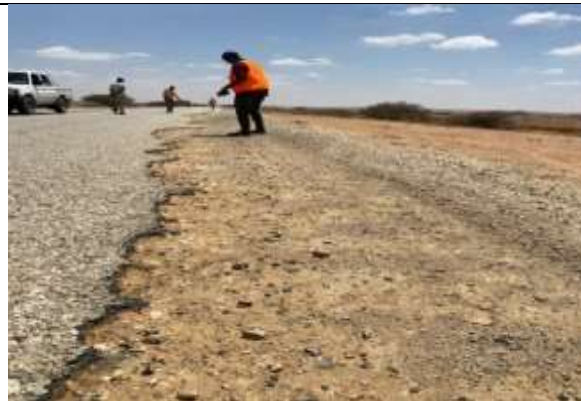
Shoulder erosion picture (RM4)  
@ Sinujiif-Dangorayo section

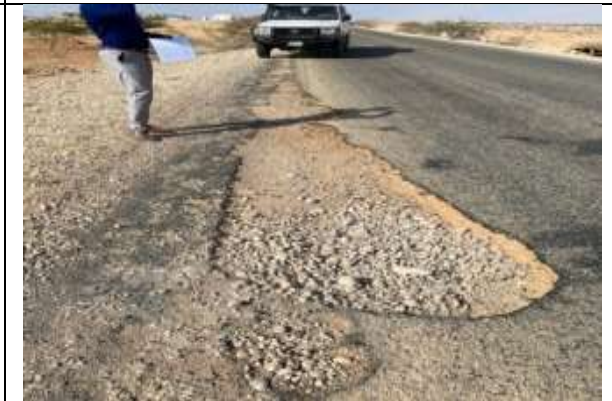
Shoulder erosion picture (RM4)  
@ Sinujiif-Dangorayo section

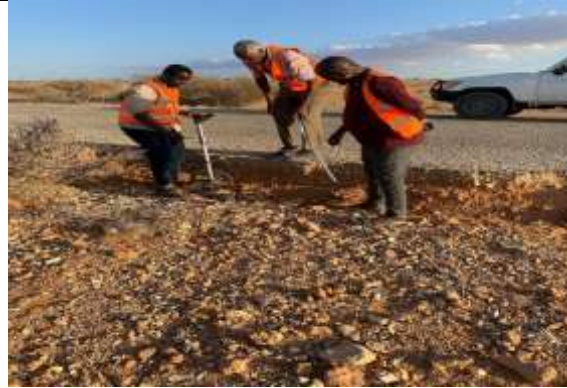
**Washed Embankment (RM5)  
@ Sinujiif-Dangoroyo section**

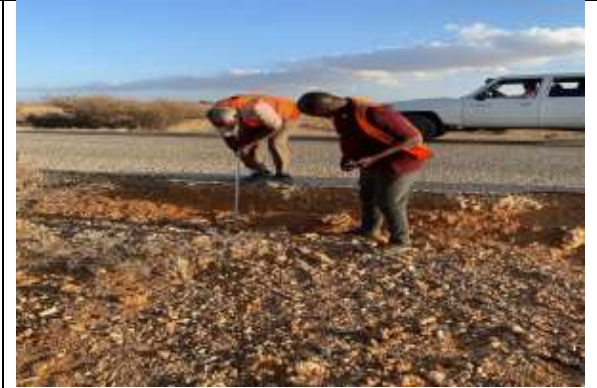
**Washed Embankment (RM5)  
@ Sinujiif-Dangoroyo section**

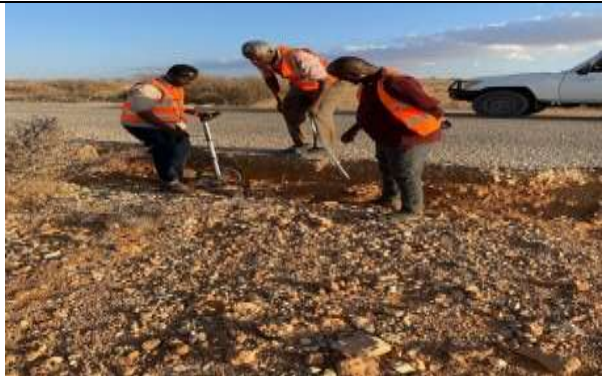
**Washed Embankment (RM5)  
@ Sinujiif-Dangoroyo section**

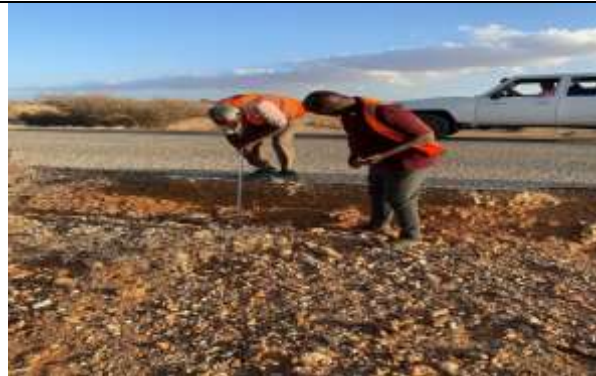
**Washed Embankment (RM5)  
@ Sinujiif-Dangoroyo section**

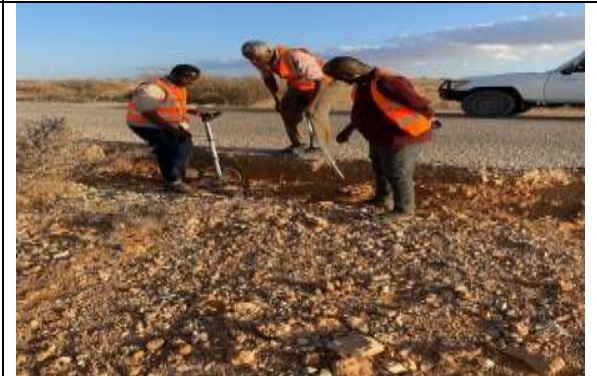
**Washed Embankment (RM5)  
@ Sinujiif-Dangoroyo section**

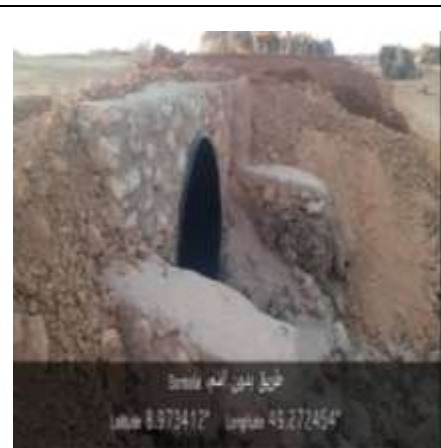
Lat8.973412  
 Long 49.272454  
 Photo 52- showing Culvert outlet

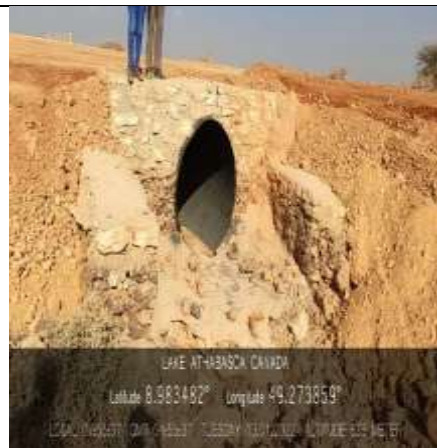
Lat8.983482  
 Long 49.273859  
 Photo 52- showing Culvert outlet

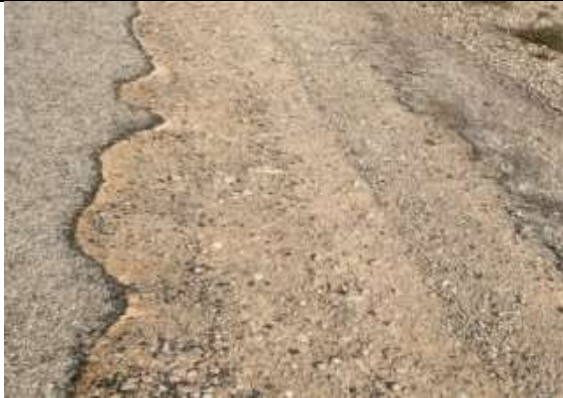
**SHOULDER EROSION (RM4)  
@ DANGORAYO-HAJI KHAYR  
SECTION**

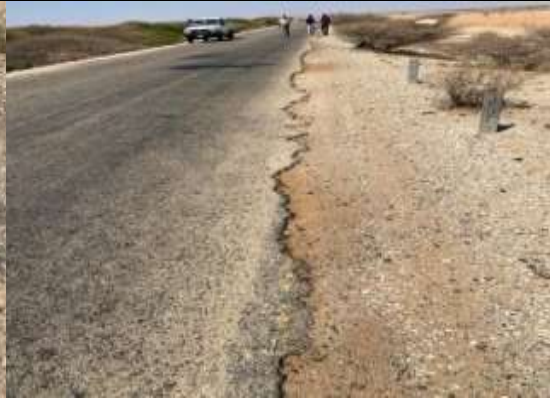
**SHOULDER EROSION (RM4)  
@ DANGORAYO-HAJI KHAYR  
SECTION**

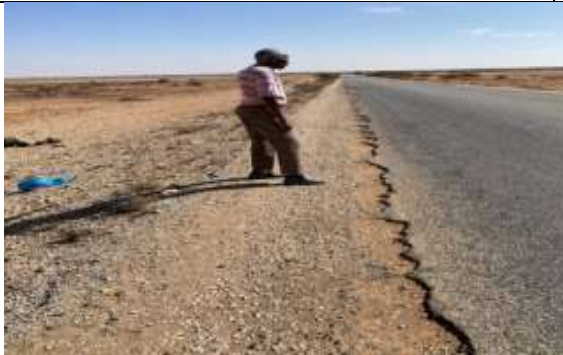
**SHOULDER EROSION (RM4)  
@ DANGORAYO-HAJI KHAYR  
SECTION**

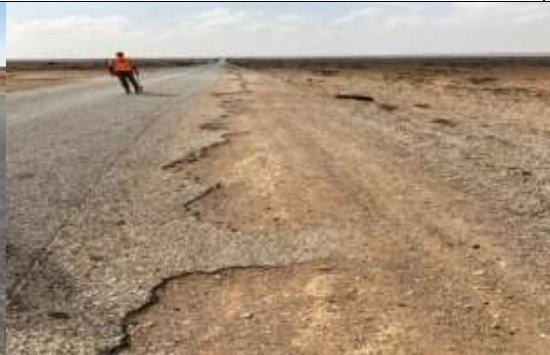
**SHOULDER EROSION (RM4)  
@ DANGORAYO-HAJI KHAYR  
SECTION**

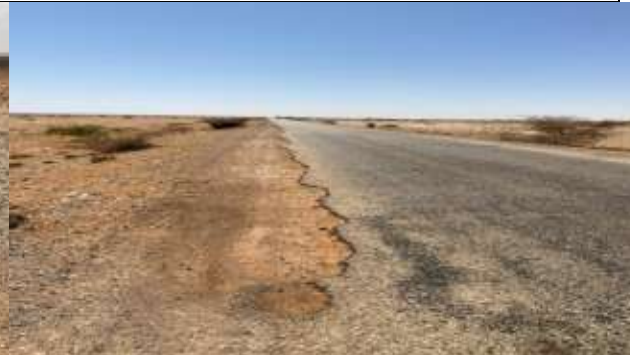
**SHOULDER EROSION (RM4)  
@ DANGORAYO-HAJI KHAYR  
SECTION**

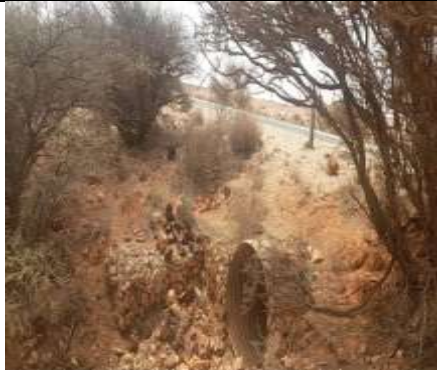
Lat 9.094832  
 Long 49.210784  
 Photo 57- showing Culvert outlet

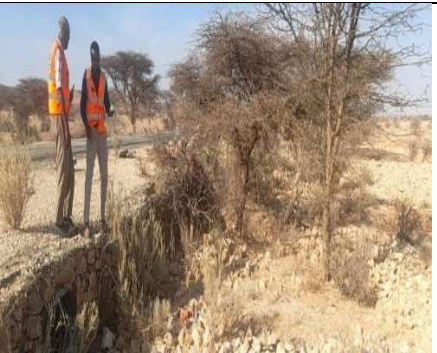
Lat 9.590487  
 Long 49.152295  
 Photo 60- showing Culvert outlet

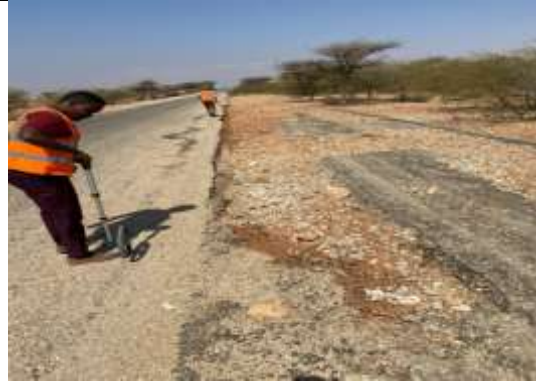
**SHOULDER EROSION (RM4)  
@ HAJI KHAYR-QARDHO SECTION**

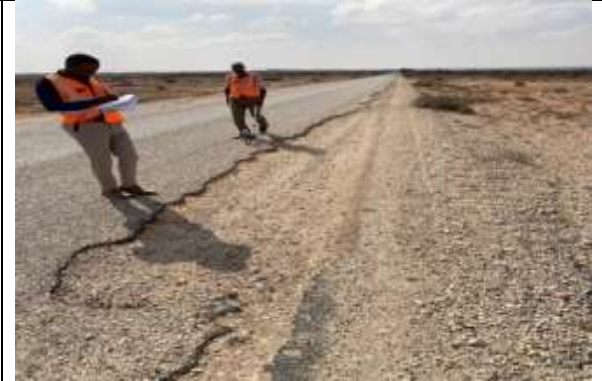
**SHOULDER EROSION (RM4)  
@ HAJI KHAYR-QARDHO SECTION**

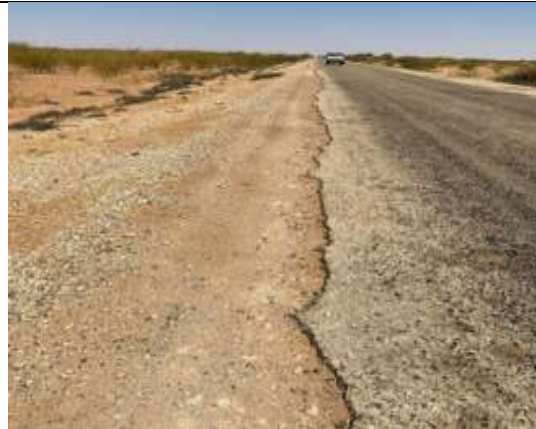
**SHOULDER EROSION (RM4)  
@ HAJI KHAYR-QARDHO SECTION**

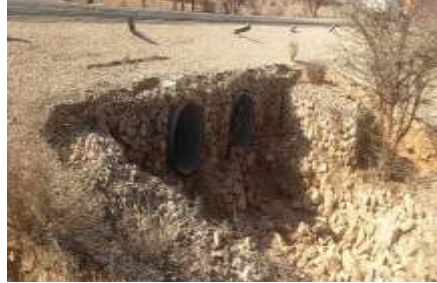
Lat 9.590488  
Long 49.152177  
Photo 61- showing Culvert outlet

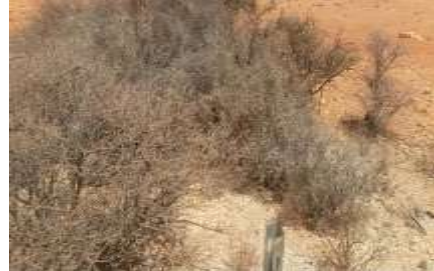
Lat 9.207592  
Long 49.129099  
Photo 62- showing Culvert outlet

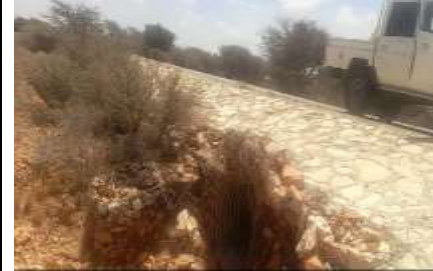
Lat 9.201505  
Long 49.132184  
Photo 63- showing Culvert outlet

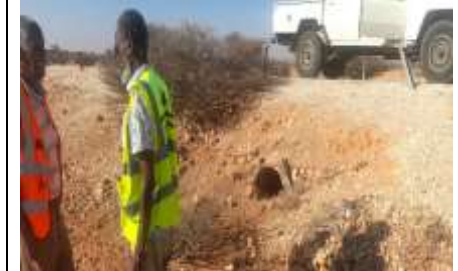
Lat 9.750158  
Long 49.195473  
Photo 70- showing Culvert outlet

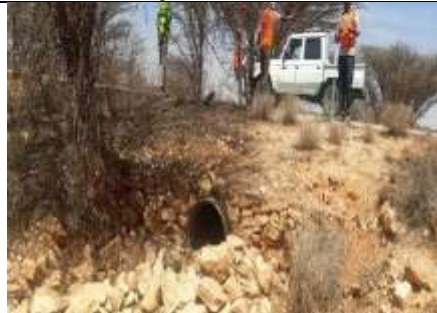
Lat 9.255913  
Long 49.106614  
Photo 64- showing Culvert outlet

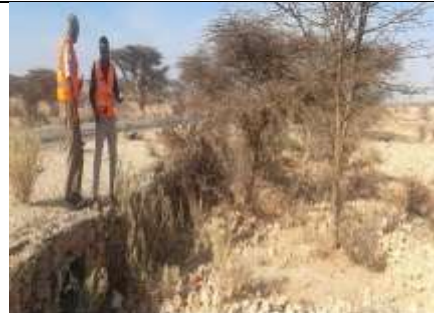
Lat 9.590487  
Long 49.152295  
Photo 65- showing Culvert outlet

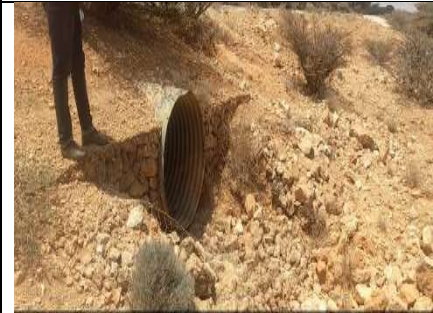
Lat 9.198716  
Long 49.133525  
Photo 66- showing Culvert outlet

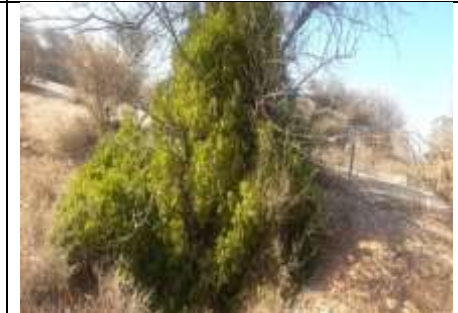
Lat 9.773629  
Long 49.188126  
Photo 71- showing Culvert outlet

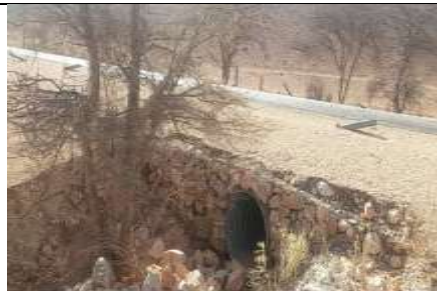
Lat 9.590824  
Long 49.152363  
Photo 67- showing Culvert outlet

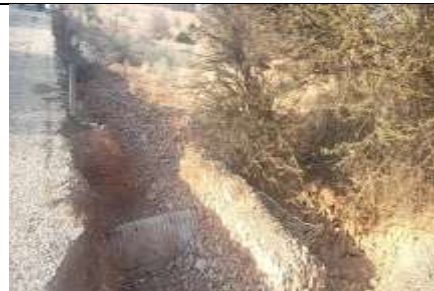
Lat 9.658915  
Long 49.174339  
Photo 68- showing Culvert outlet

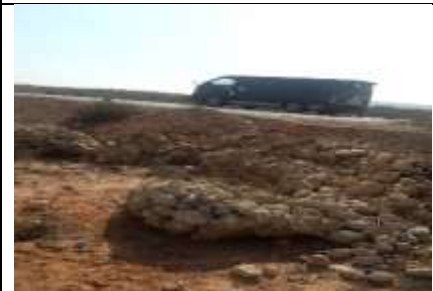
Lat 10.497692  
Long 49.074262  
Photo 69- showing Culvert outlet

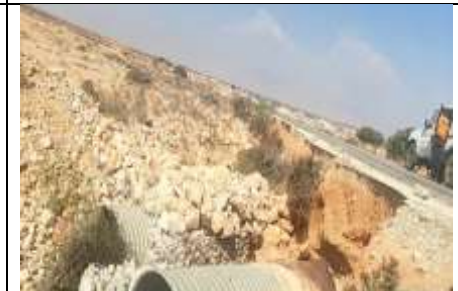
Lat 10.497692  
Long 49.074262  
Photo 72- showing Culvert outlet

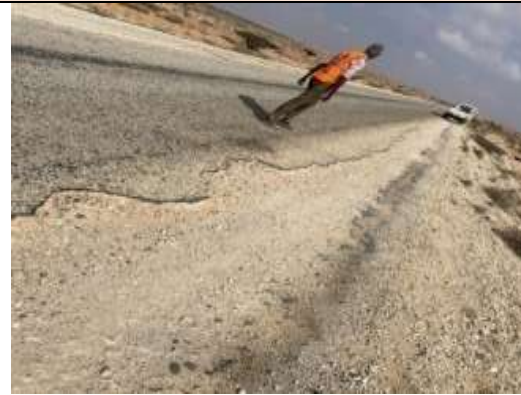
**SHOULDER EROSION (RM4)  
@ GARDO-WACIYE SECTION**

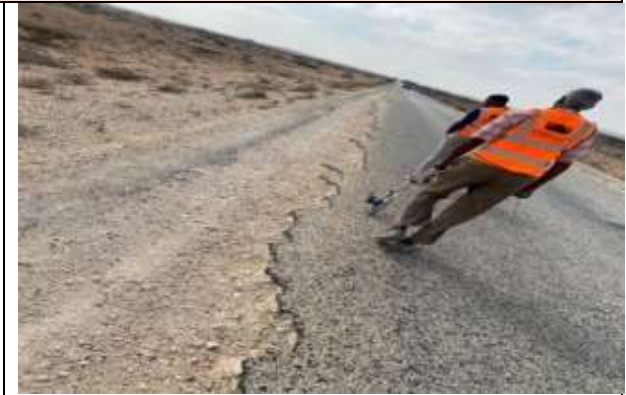
**SHOULDER EROSION (RM4)  
@ GARDO-WACIYE SECTION**

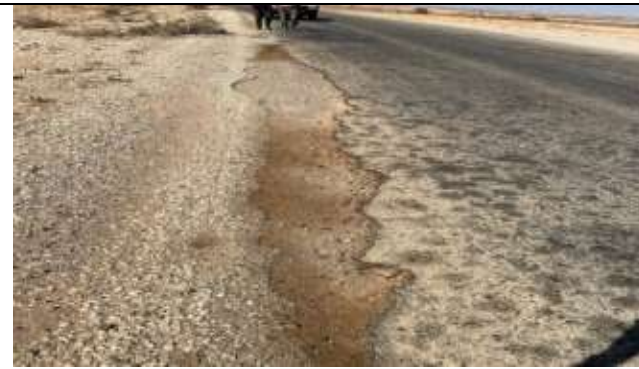
**SHOULDER EROSION (RM4)  
@ GARDO-WACIYE SECTION**

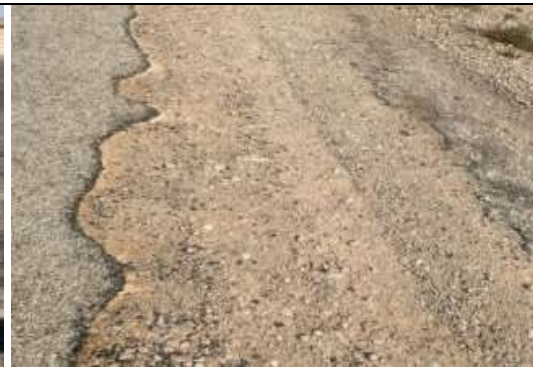
**SHOULDER EROSION (RM4)  
@ GARDO-WACIYE SECTION**

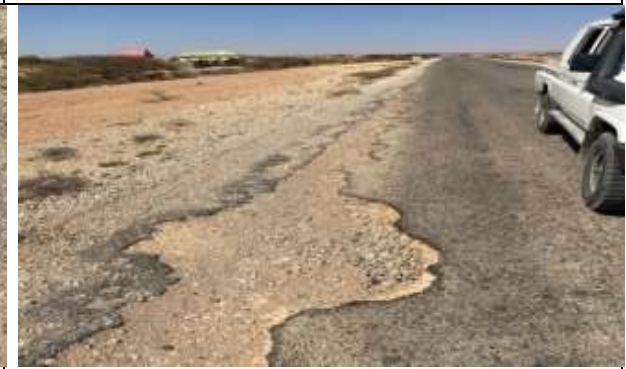
**SHOULDER EROSION (RM4)  
@ GARDO-WACIYE SECTION**

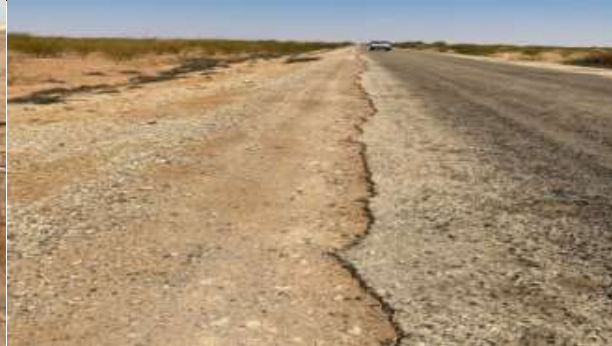
**SHOULDER EROSION (RM4)  
@WACIYE-ARMO SECTION**

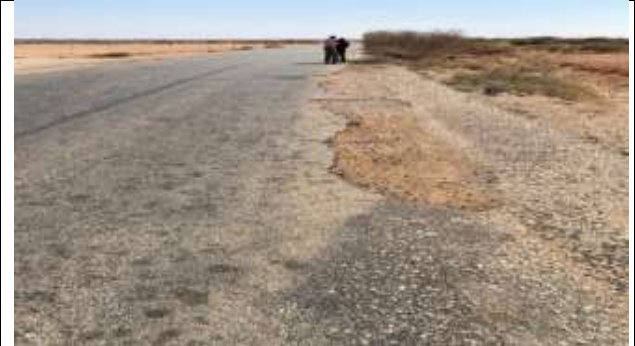
**SHOULDER EROSION (RM4)  
@WACIYE-ARMO SECTION**

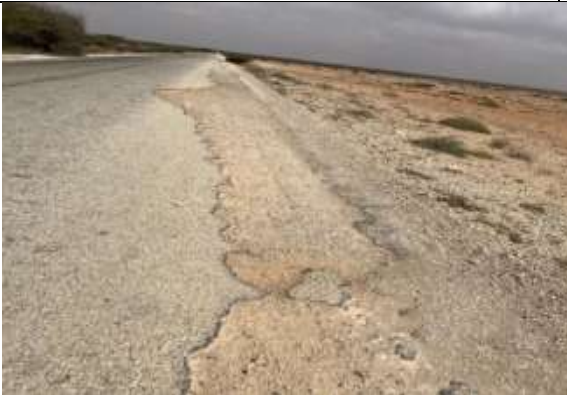
**SHOULDER EROSION (RM4)  
@WACIYE-ARMO SECTION**

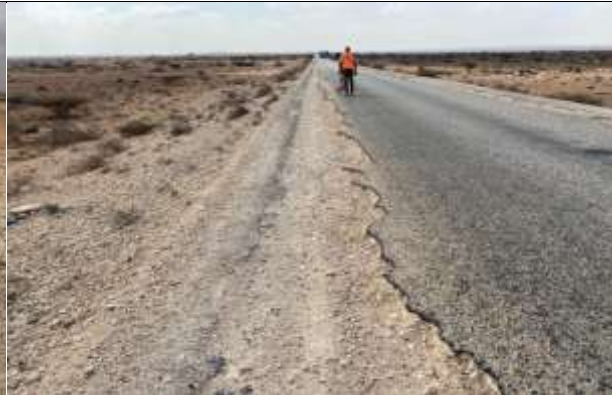
**SHOULDER EROSION (RM4)  
@WACIYE-ARMO SECTION**

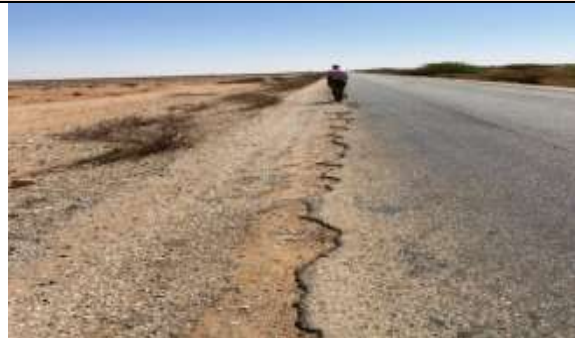
✓ Team observed on this Section 4.200km Defected Shoulder

**SHOULDER EROSION (RM4)@  
ARMO-BOSASO SECTION**

Table 28: Shoulder Erosion for Section 7- Carmo-Bosaso									
No.	Start Coordinates		End coordinates		L	W	D	Shoulder Defects (RM4)	Proposed Improvement Measures
142	10.59574° N	49.05083° E	11.213 44°N	49.19156°N	2350	0.6	0.05	Shoulder erosion	Construction of shoulder pavement and applying single surface dressing
143	10.59574° N	49.05083° E	11.213 44°N	49.19156°N	1850	0.5	0.05	Shoulder erosion	Construction of shoulder pavement and applying single surface dressing

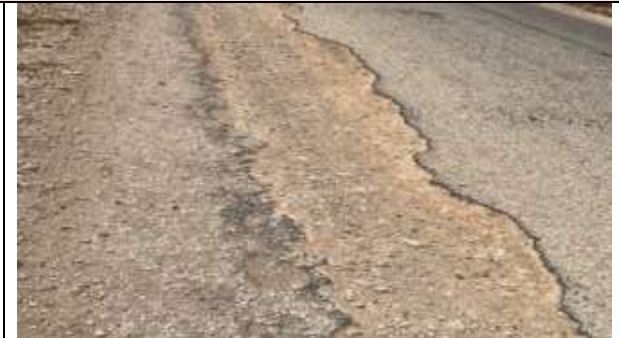
**SHOULDER EROSION (RM4)  
@ ARMO-BOSASO SECTION**

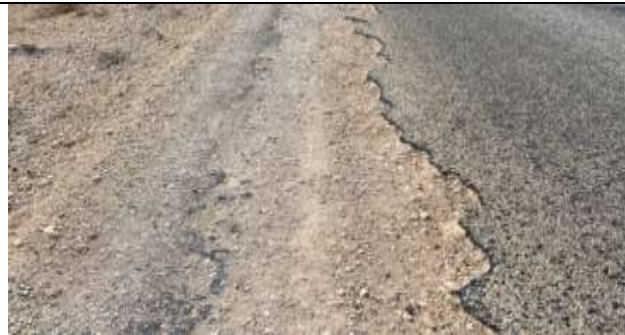
**SHOULDER EROSION (RM4)  
@ ARMO-BOSASO SECTION**

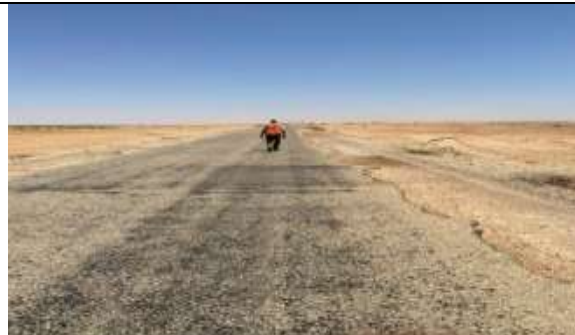
**SHOULDER EROSION (RM4)@  
ARMO-BOSASO SECTION**

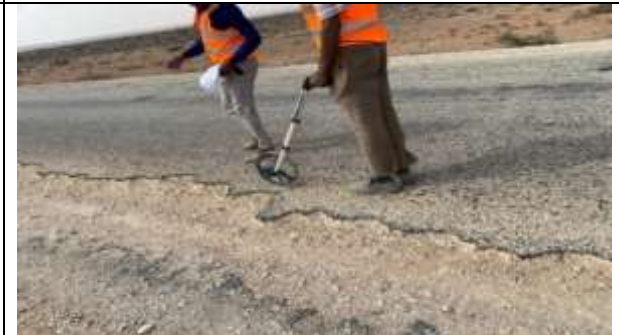
**SHOULDER EROSION (RM4)  
@ ARMO-BOSASO SECTION**
