PUNTLAND HIGHWAY  
AUTHORITY

ROAD CONDITION  
ASSESSMENT SURVEY  
REPORT

GAROWE – BOSASO TARMAC  
ROAD

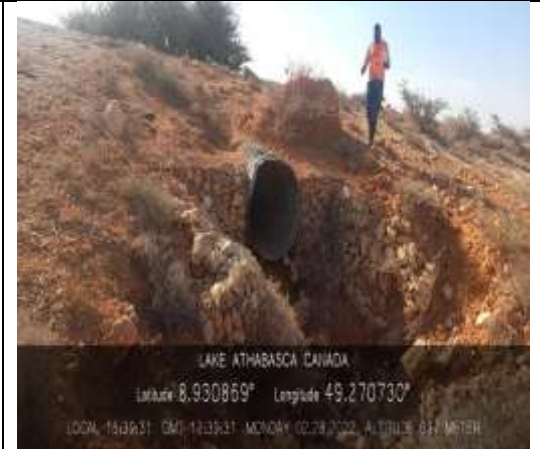
LAKE ATHABASCA CANADA  
 Latitude: 8.930869° Longitude 49.270730°  
 LOCAL 162124 GMT 132124 MONDAY 02.28.2022 ALTITUDE 817 METER

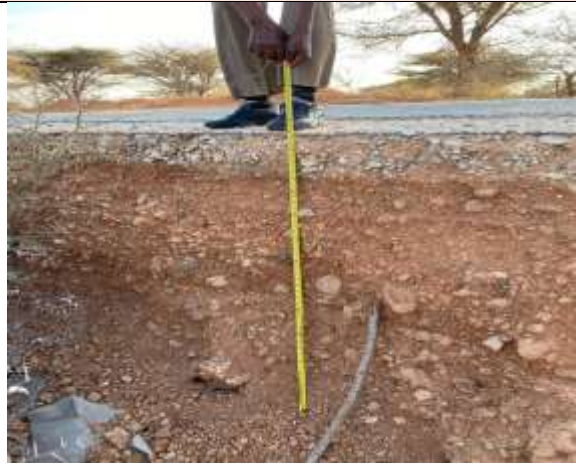
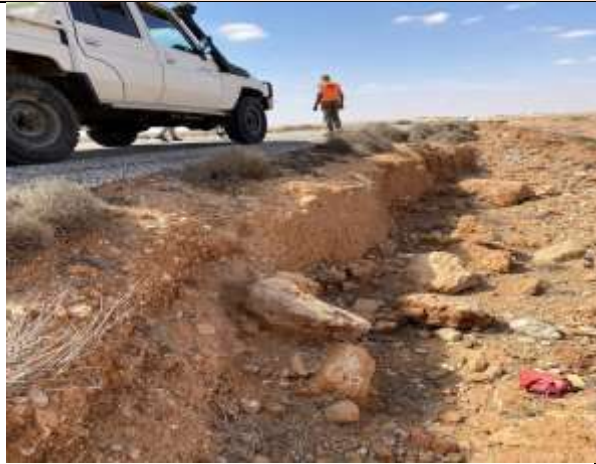
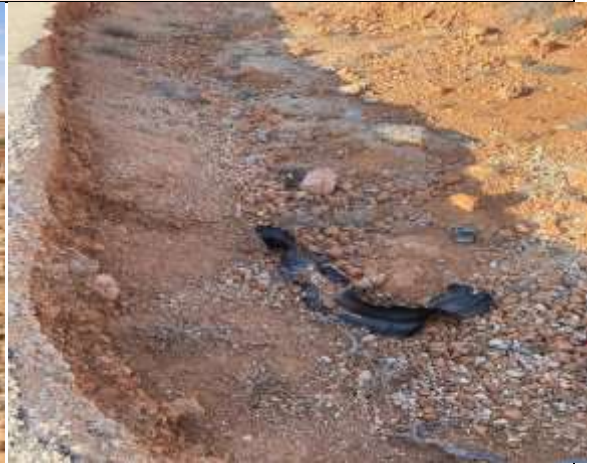
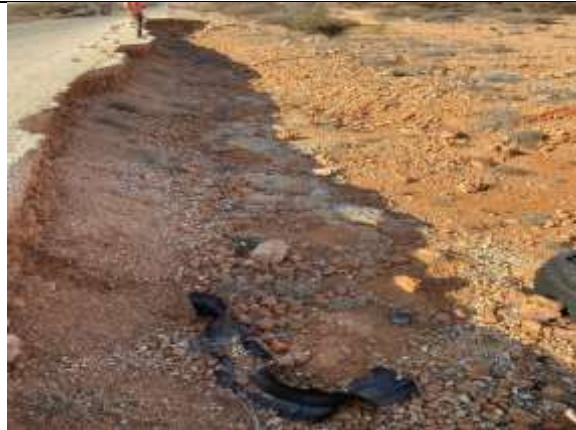
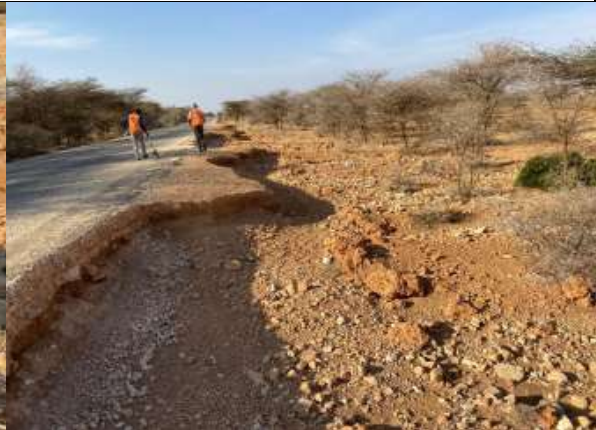
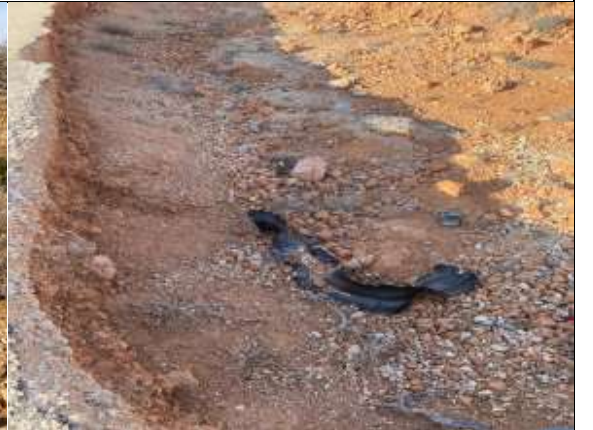
**8.3.8 Photos : Washed Embankment for Section 3- Dangoroyo-Haji Khayr**

8	8.85 841° N	49.27308° E	8.86176° N	49.27288° E	375	1.6	Washed embankment	Excavation and removal of all debris materials and filling and compacting by layers from approval material in order to restore the original shape.
9	8.86 176° N	49.27288° E	8.86382° N	49.27274° E	275	0.5	Washed embankment	Excavation and removal of all debris materials and filling and compacting by layers from approval material in order to restore the original shape.
10	8.88 917° N	49.27168° E	8.89205° N	49.27153° E	310	0.7	Washed embankment	Excavation and removal of all debris materials and filling and compacting by layers from approval material in order to restore the original shape.

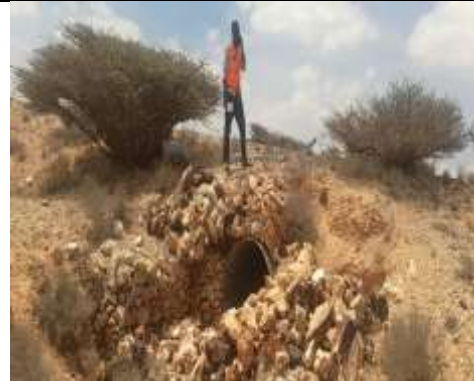
Lat 9.114340  
 Long 49.199204  
 Photo 59- showing Culvert outlet

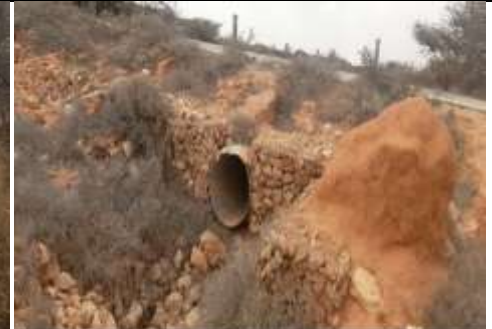
LAKE ATHABASCA CANADA  
Latitude 9.071737° Longitude 49.223134°  
LOCAL 111636 DAT 162833 TUESDAY 03/11/2017 ALTITUDE 732 METERS

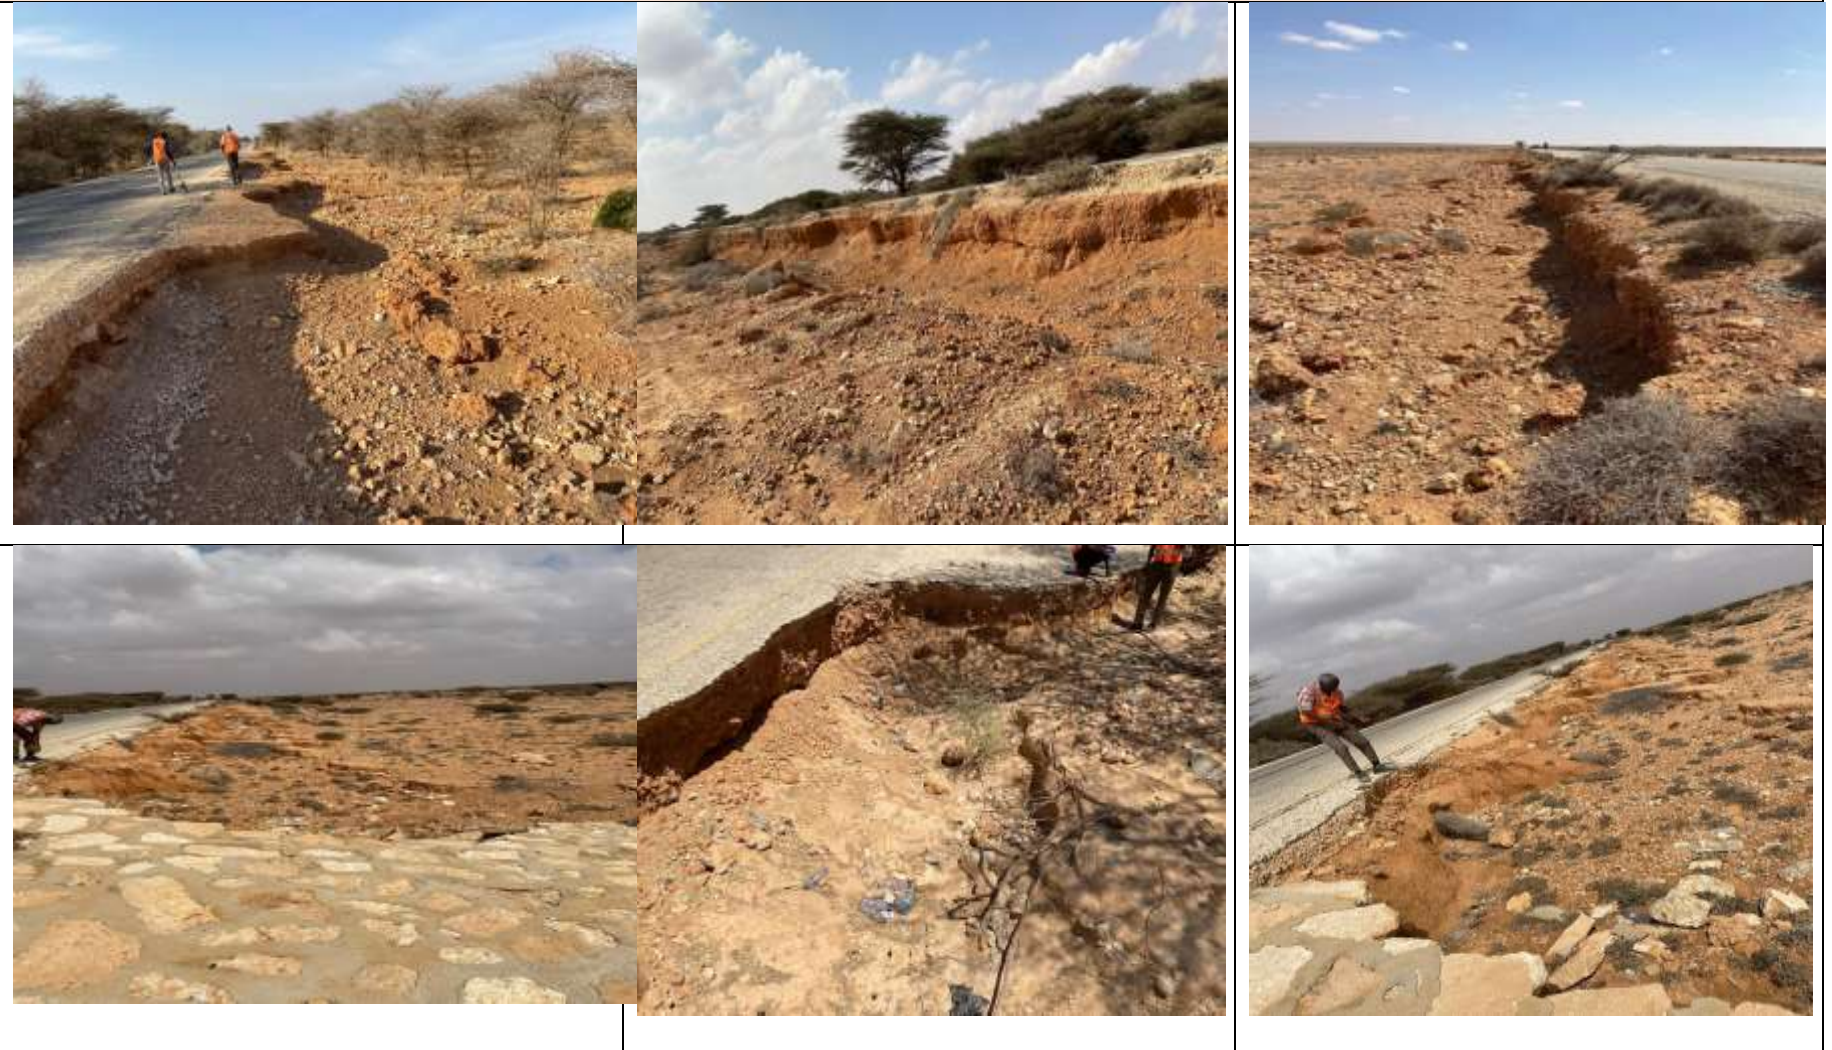
**8.4.8 Photos: Washed Embankment for Section 4- Haji Khayr-Qardho**

15	9.02867 °N	49.24406°E	9.0321 0°N	49.24270°E	455	1	Washed embankment	Excavation and removal of all debris materials and filling and compacting by layers from approval material in order to restore the original shape.
16	9.06819 °N	49.22559°E	9.0684 6°N	49.22542°E	43	0.8	Washed embankment	Excavation and removal of all debris materials and filling and compacting by layers from approval material in order to restore the original shape.
17	9.06987 °N	49.22472°E	9.0717 9°N	49.22364°E	175	0.9	Washed embankment	Excavation and removal of all debris materials and filling and compacting by layers from approval material in order to restore the original shape.

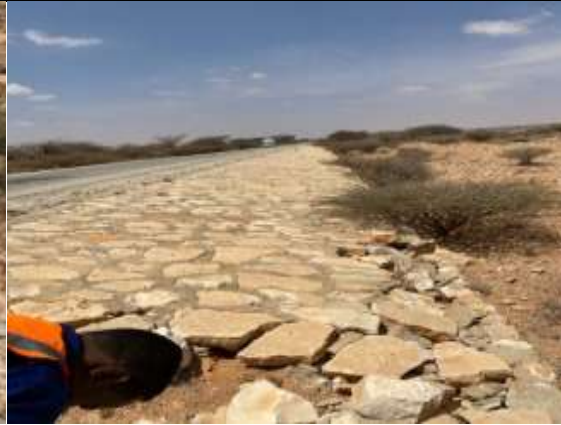
**Stone pitching (RM5)  
@ Haji khayr-Gardo Section**

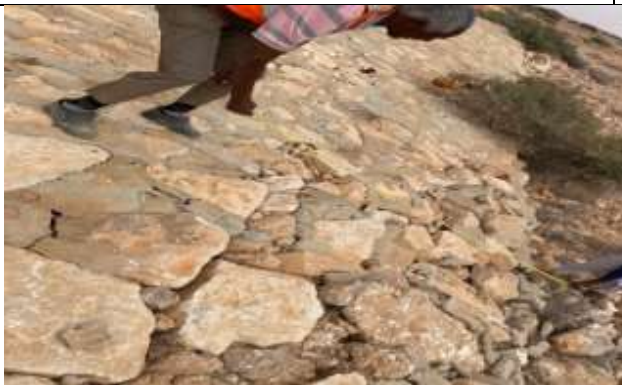
**Stone pitching (RM5)  
@ Haji khayr-Gardo Section**

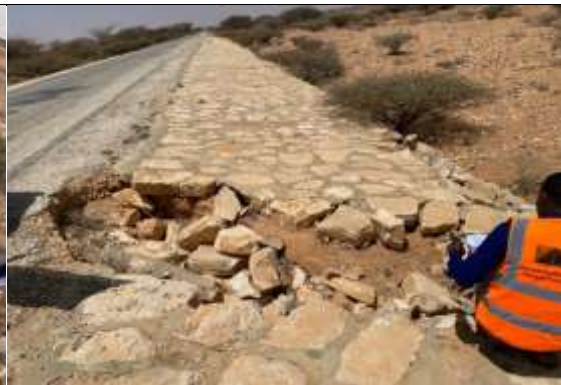
**Stone pitching (RM5)  
@ Haji khayr-Gardo Section**

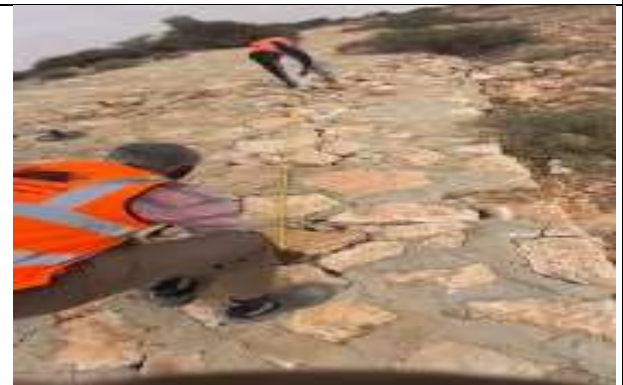
**Stone pitching (RM5)  
@ Haji khayr-Gardo Section**

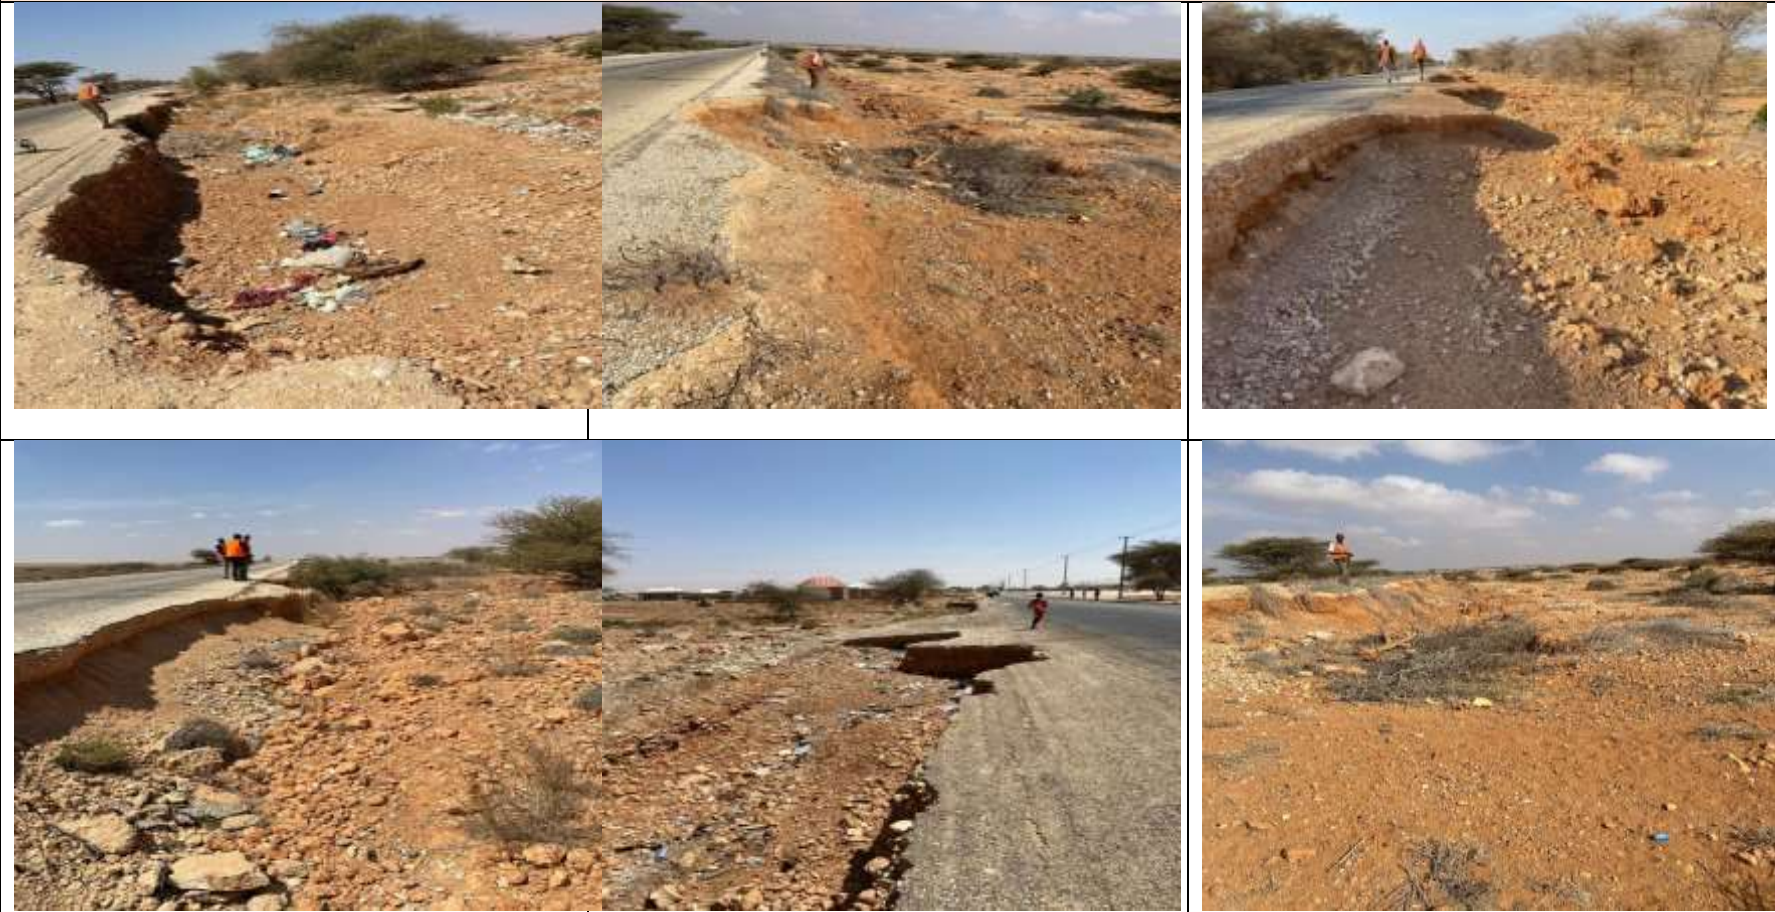
**8.5.8 Photos: Washed Embankment for Section 5- Qardho –Waaciye**

NO	START COORDINATES		END COORDINATES		LENGTH	AVERAGE DEPTH	DEFECTS (RM5)	Proposed improvement measure
18	9.62372° N	49.17437° E	9.62676° N	49.17446° E	336	0.8	Washed embankment	Excavation and removal of all debris materials and filling and compacting by layers from approval material in order to restore the original shape.
19	9.65769° N	49.17506° E	9.65957° N	49.17509° E	315	0.95	Washed embankment	Excavation and removal of all debris materials and filling and compacting by layers from approval material in order to restore the original shape.
20	9.68882° N	49.17563° E	9.69058° N	49.17567° E	211	0.9	Washed embankment	Excavation and removal of all debris materials and filling and compacting by layers from approval material in order to restore the original shape.
21	9.83440° N	49.13054° E	9.83542° N	49.12991° E	162	0.9	Washed embankment	Excavation and removal of all debris materials and filling and compacting by layers from approval material in order to restore the original shape.

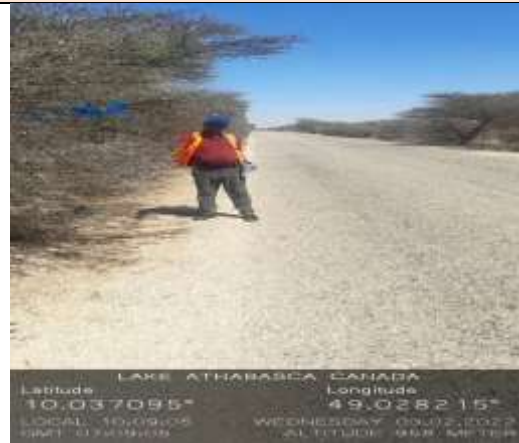
**8.5.10 Photos: Overgrown Vegetation for Section 5- Qardho –Waaciye**

9.89513°N	49.07049°E	9.89736°N	49.06576°E	800	branches are reaching over the carriage way narrowing the traffic lines in very dangerous way	Removeall thorn bush and trees that are overgrowing on the shoulders, embankmentand the side drains.

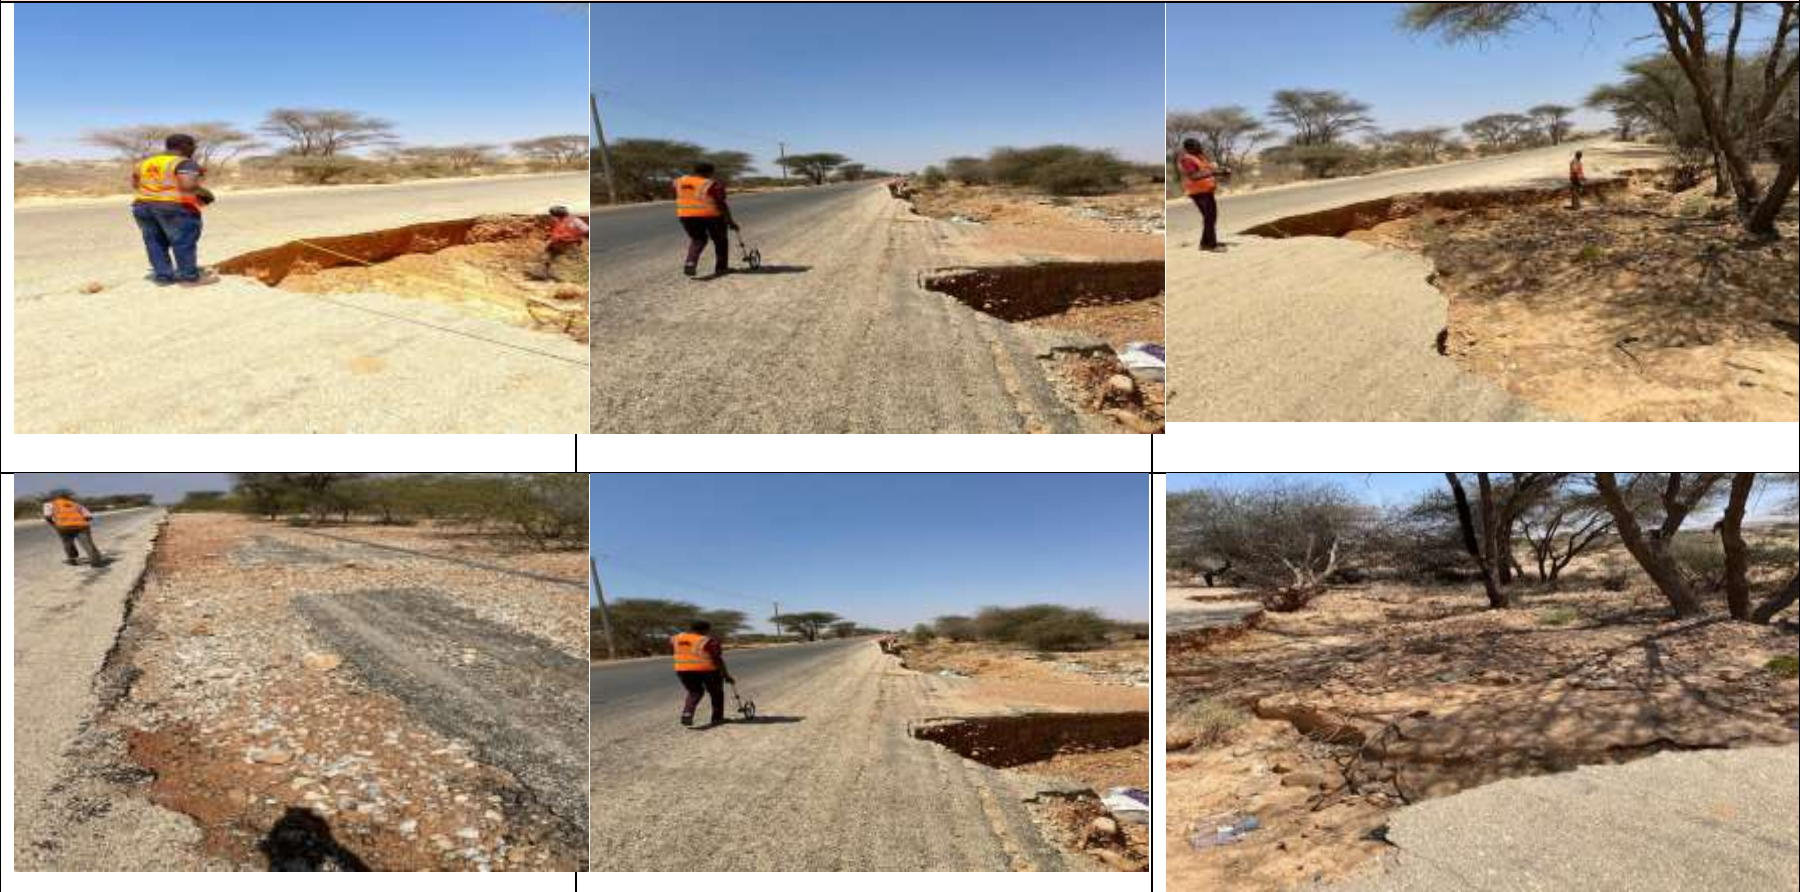
**8.6.8 Photos: Washed Embankment for Section 6- Waaciye-Carmo**

Table 24: Status of Washed Embankment for Section 6- Waaciye-Carmo								
NO	START COORDINATES		END COORDINATES		LENGTH	AVERAG E DEPTH	DEFECTS (RM5)	Proposed improvement measure
22	10.32543° N	49.05743° E	10.32640 °N	49.05743° E	110	1.1	Washed embankment	Excavation and removal of all debris materials and filling and compacting by layers from approval material in order to restore the original shape.
23	10.39115° N	49.08203° E	10.39177 °N	49.08393° E	56	1.7	Washed embankment	Excavation and removal of all debris materials and filling and compacting by layers from approval material in order to restore the original shape.
24	10.42031° N	49.09283° E	10.42804 °N	49.09256° E	190	0.7	Washed embankment	Excavation and removal of all debris materials and filling and compacting by layers from approval material in order to restore the original shape.
25	10.49691° N	49.07505° E	10.49930 °N	49.07430° E	250	1.2	Washed embankment	Excavation and removal of all debris materials and filling and compacting by layers from approval material in order to restore the original shape.

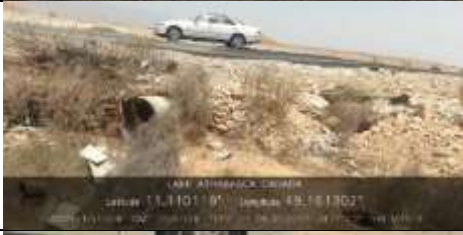
15	Lat 11.116610 <sup>0</sup> Long 49.155226 <sup>0</sup>	1.5	24	Single	Rusted /Replacement required	 
16	Lat 11.101578 <sup>0</sup> Long 49.168509 <sup>0</sup>	0.8	25	Single	Rusted /Replacement required

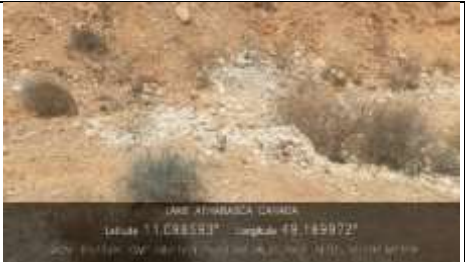
20	Lat 11.088593 <sup>0</sup> Long 49.189972 <sup>0</sup>	1.5	27	Single	Rusted /Replacement required

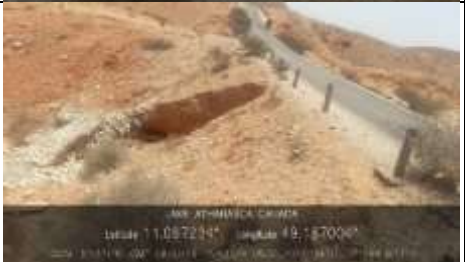
21	Lat 11.067234 <sup>0</sup> Long 49.187004 <sup>0</sup>	1.5	23	Single	Rusted /Replacement required

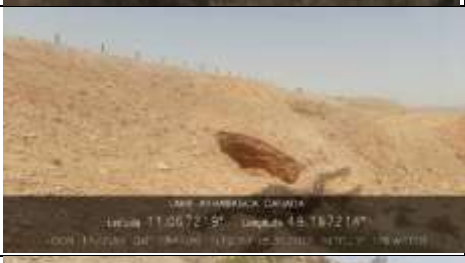
22	Lat 11.067219 <sup>0</sup> Long 49.187214 <sup>0</sup>	1.5	42	Single	Rusted /Replacement required

**RM6** : Total replacement of the corrugated iron pipe culverts(New).

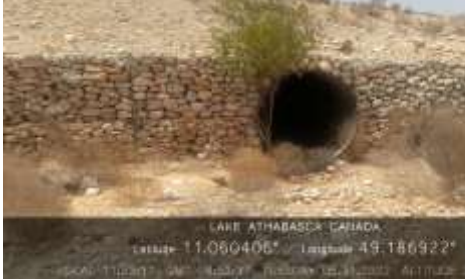
23	Lat 11.060406 <sup>0</sup> Long 49.186922 <sup>0</sup>	1	27	Single	Rusted /Replacement required

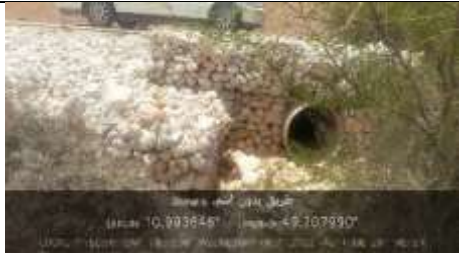
43	Lat 10.993646 <sup>0</sup> Long 49.207990 <sup>0</sup>	1	14	Single	Rusted /Replacement required

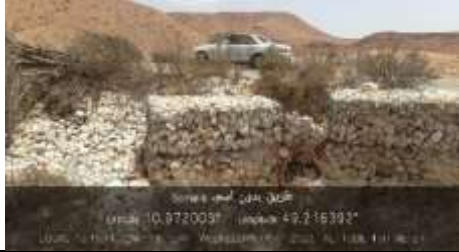
44	Lat 10.972003 <sup>0</sup> Long 49.216392 <sup>0</sup>	0.8	16	Single	Rusted /Replacement required

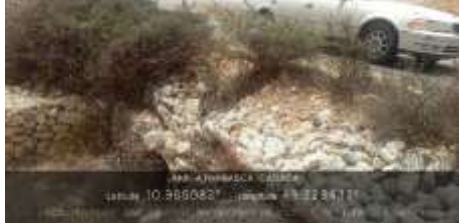
45	Lat 10.965082 <sup>0</sup> Long 49.223432 <sup>0</sup>	1.5	16	Single	Rusted /Replacement required

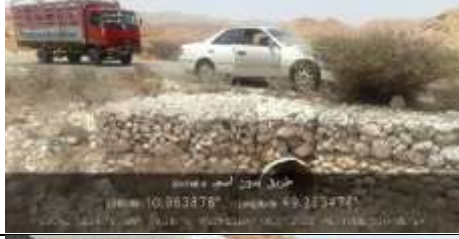
46	Lat 10.963878 <sup>0</sup> Long 49.223478 <sup>0</sup>	1.5	17	Single	Rusted /Replacement required

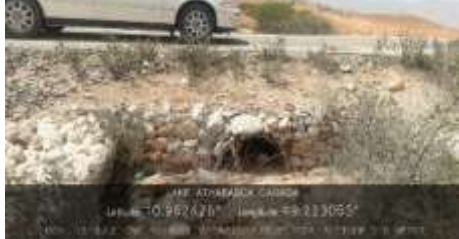
47	Lat 10.962426 <sup>0</sup> Long 49.223055 <sup>0</sup>	1	20	Single	Rusted /Replacement required

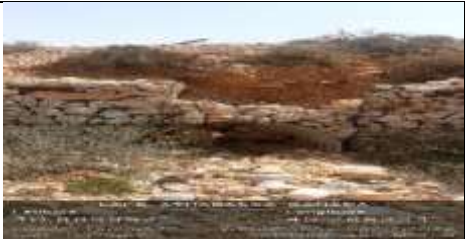
48	Lat 10.889992 <sup>0</sup> Long 49.266331 <sup>0</sup>	1.5	29	Single	Rusted /Replacement required

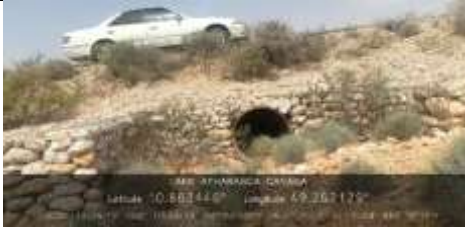
49	Lat 10.862446 <sup>0</sup> Long 49.262129 <sup>0</sup>	1	24	Single	Rusted /Replacement required

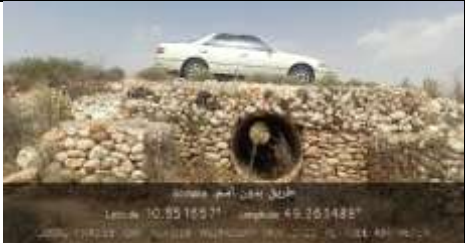
50	Lat 10.851657 <sup>0</sup> Long 49.261488 <sup>0</sup>	1	21	Single	Rusted /Replacement required

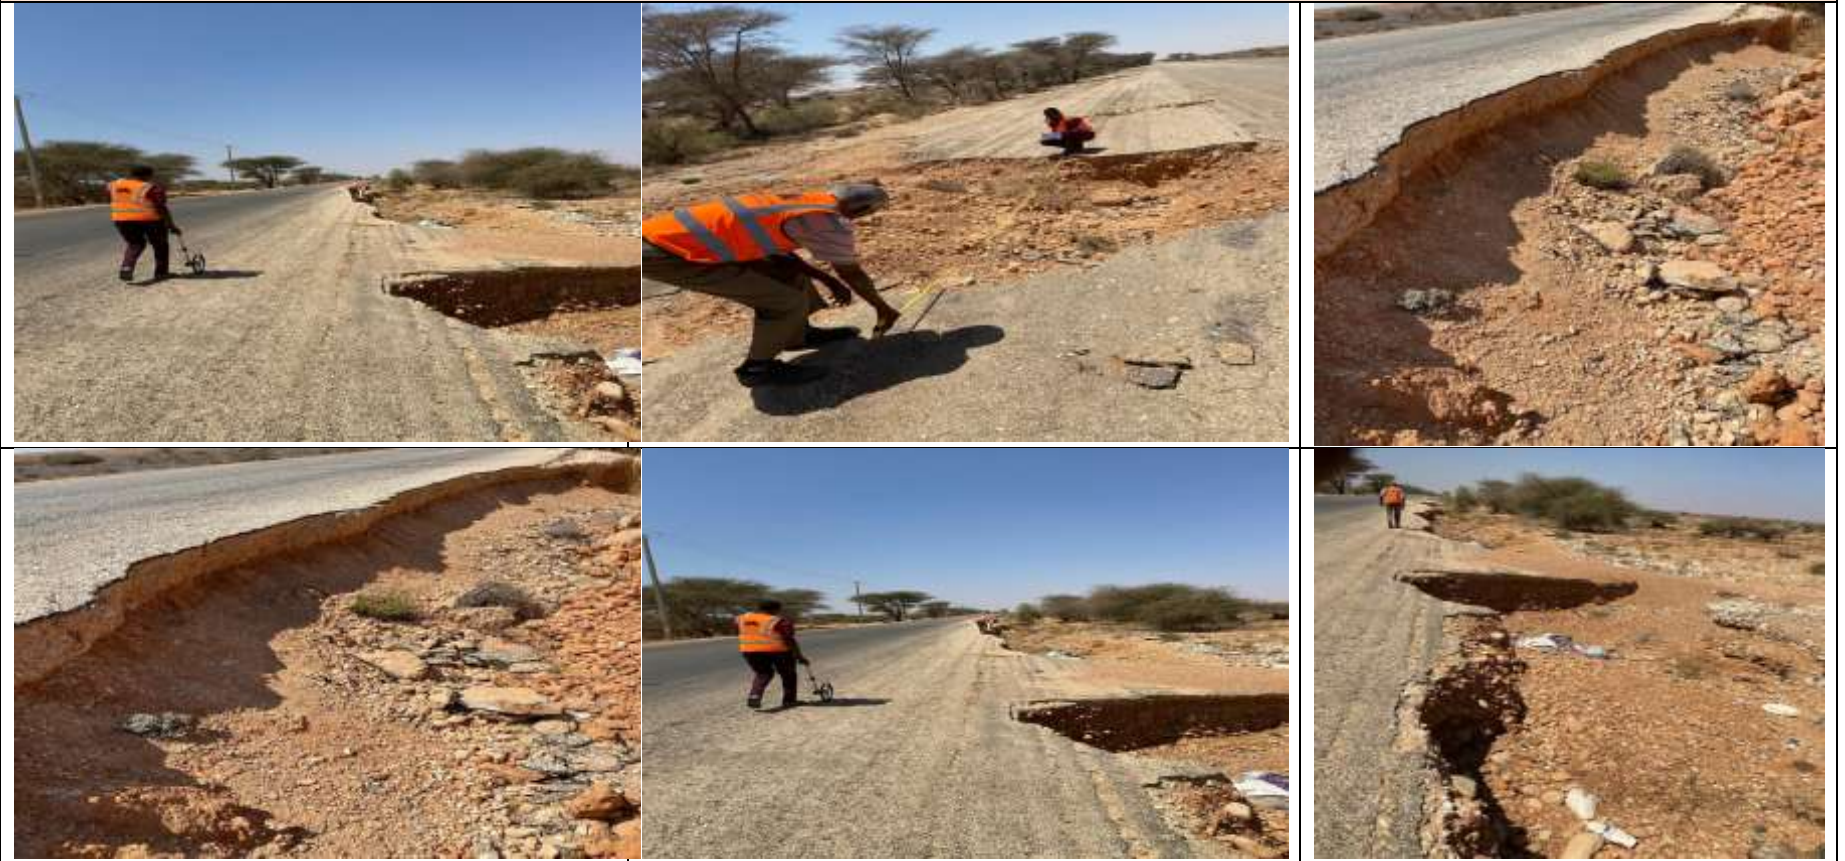
**8.7.6 Photos: Washed Embankment for Section 7- Carmo-Bosaso**

Table 29: Status of Washed Embankment for Section 7- Carmo-Bosaso								
NO	START COORDINATES		END COORDINATES		LENGTH	AVERAGE DEPTH	DEFECTS (RM5)	Proposed improvement measure
26	10.71980° N	49.14669° E	10.72054°N	49.14769° E	160	0.5	Washed embankment	Excavation and removal of all debris materials and filling and compacting by layers from approval material in order to restore the original shape.
27	10.76831° N	49.21428° E	10.76926°N	49.21471° E	60	0.2	Washed embankment	Excavation and removal of all debris materials and filling and compacting by layers from approval material in order to restore the original shape.
28	10.76925° N	49.21470° E	10.76939°N	49.21479° E	32	1.1	Washed embankment	Excavation and removal of all debris materials and filling and compacting by layers from approval material in order to restore the original shape.
29	10.79179° N	49.22189° E	10.79941°N	49.22271° E	220	0.8	Washed embankment	Excavation and removal of all debris materials and filling and compacting by layers from approval material in order to restore the original shape.

**RM5** : Repair erosion lining and scour protection.
